Department of Veterans Affairs JAHVA/Tampa, FL

IPP roofing product demonstration, applications for different roof systems.

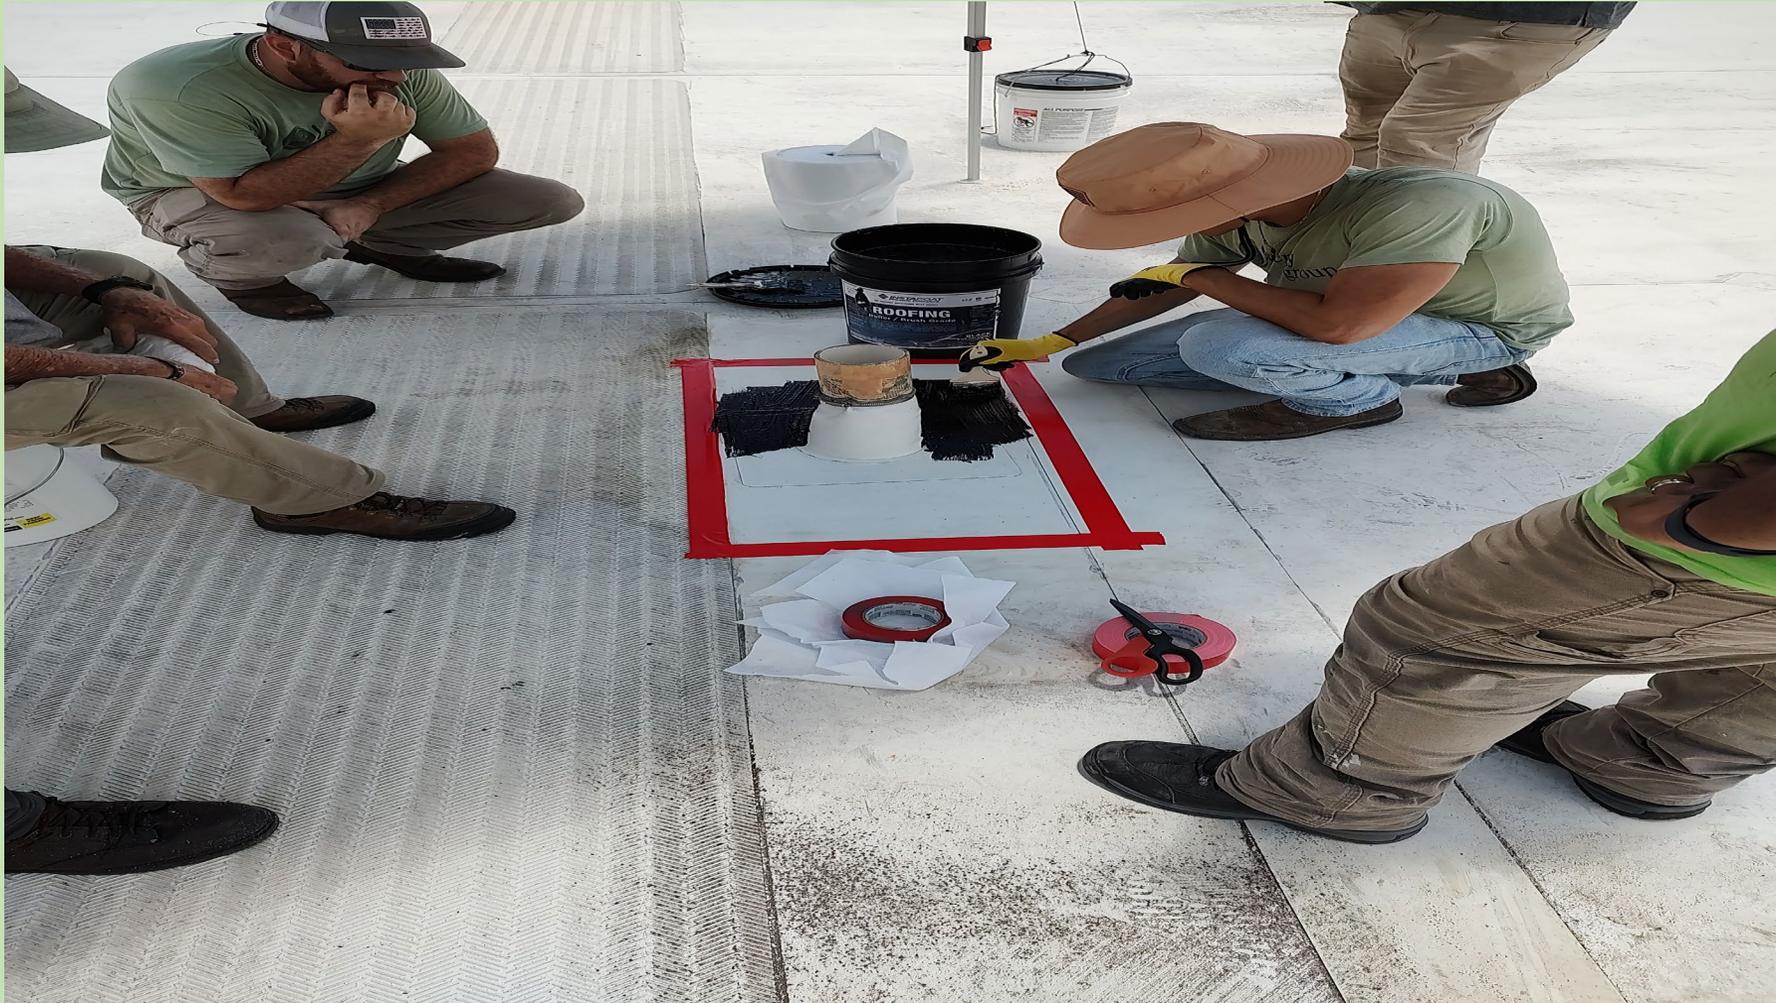
TPO/EPDM/PVC Pressure wash old membranes using IPP Wash and Prime cleaning solution. This process removes dirt and the oxidized top layer on rubber membranes. The membrane on the right was cleaned prior to applying the rubber emulsion, after curing the top coat will be applied.

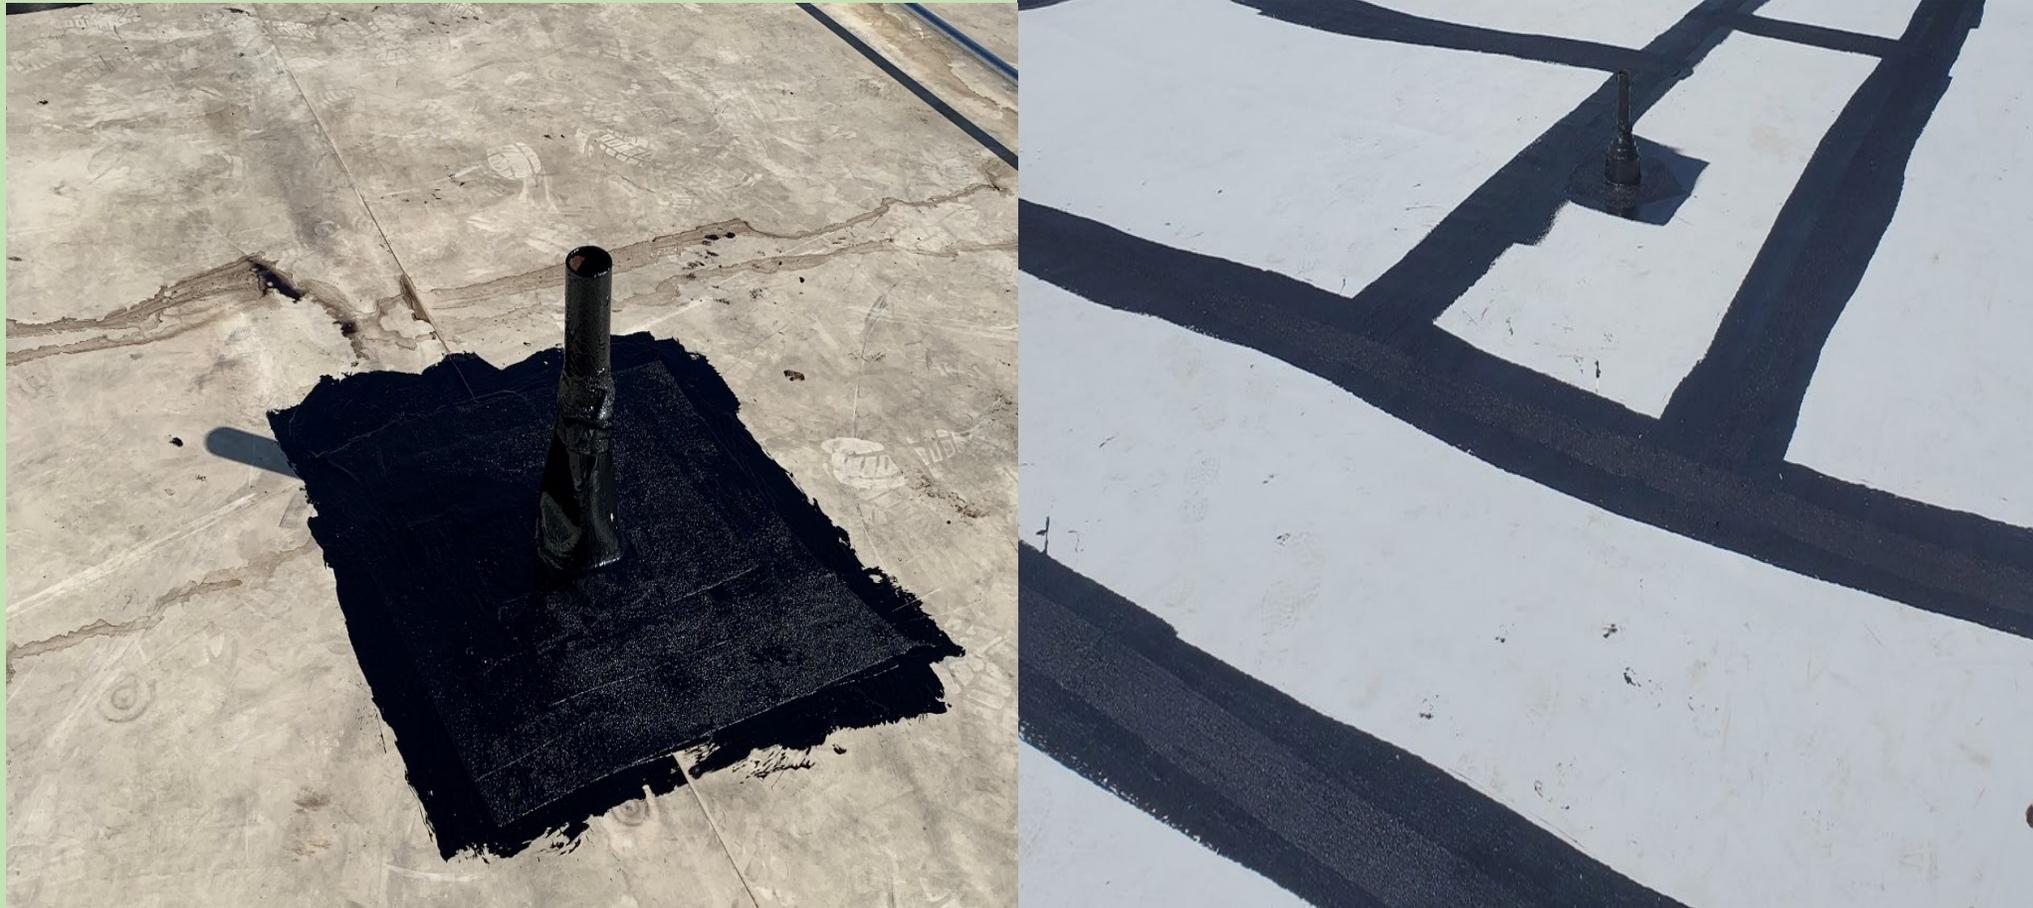
Drains/Scuppers/Seams, are the #1 source of leaks and failed membranes.

This picture is a cap-sheet which was coated several years ago with a white acrylic top coat. The drain is boxed in and clogged, causing ponding water. The capsheet and acrylic coating are made from organic compounds and breakdown in water over time and fail. Silicone is an inorganic compound and does not breakdown in water, which is the perfect material for a flat roof.

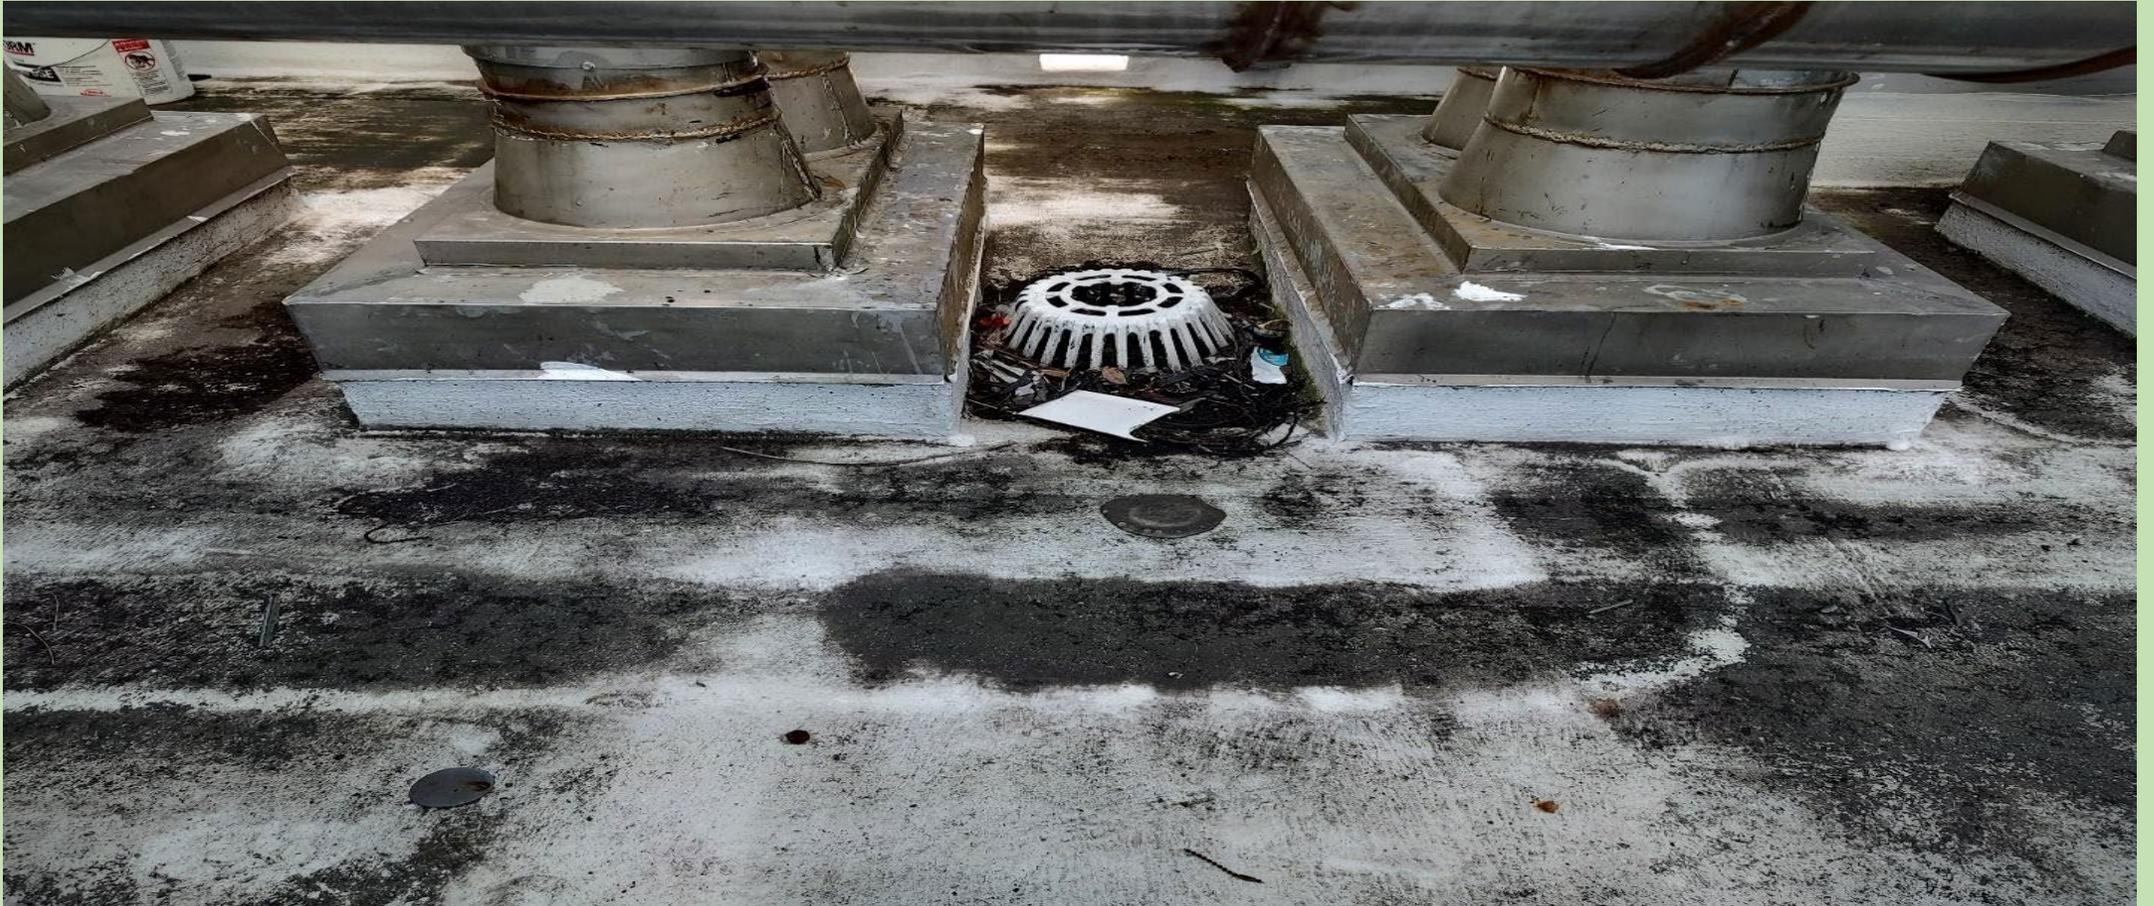
Rubber asphalt emulsion is used around roof drains and reinforced by embedding fabric into the rubber. Preventative Maintenance at drains will seal the area and prevent roof leaks. Failed drains and seams are the #1 source of roof leaks.

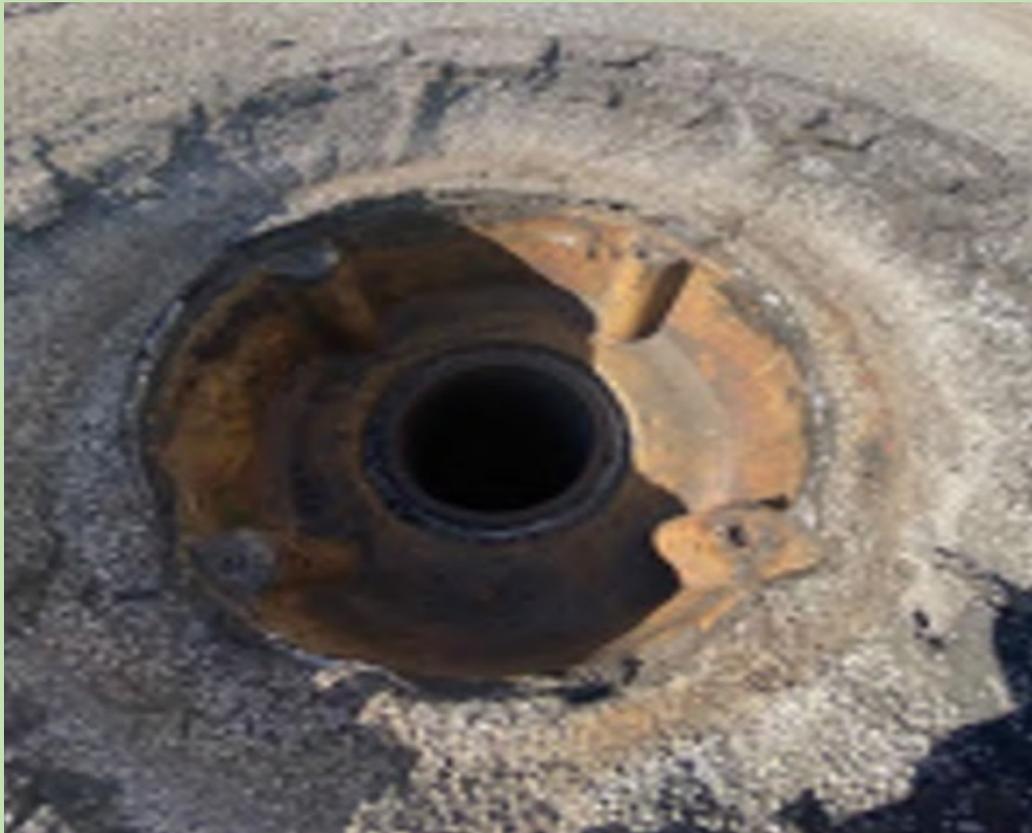
Drain cap/ring removed and cleaned.

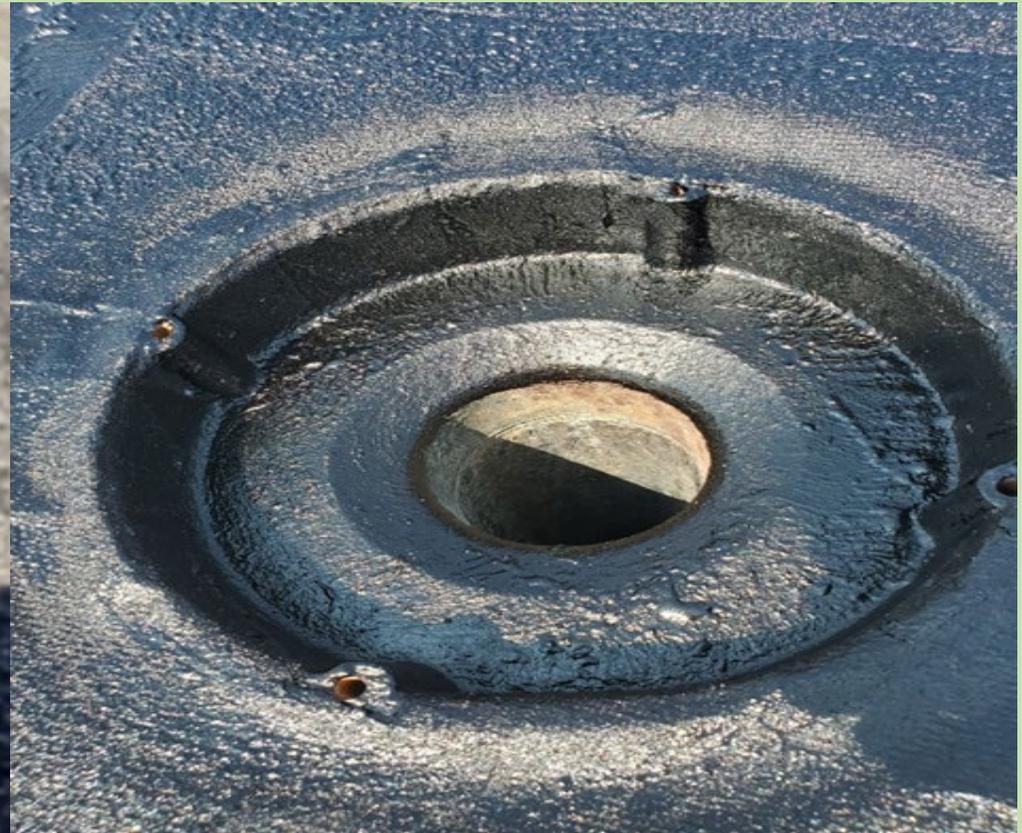
Drain coated with rubber emulsion.

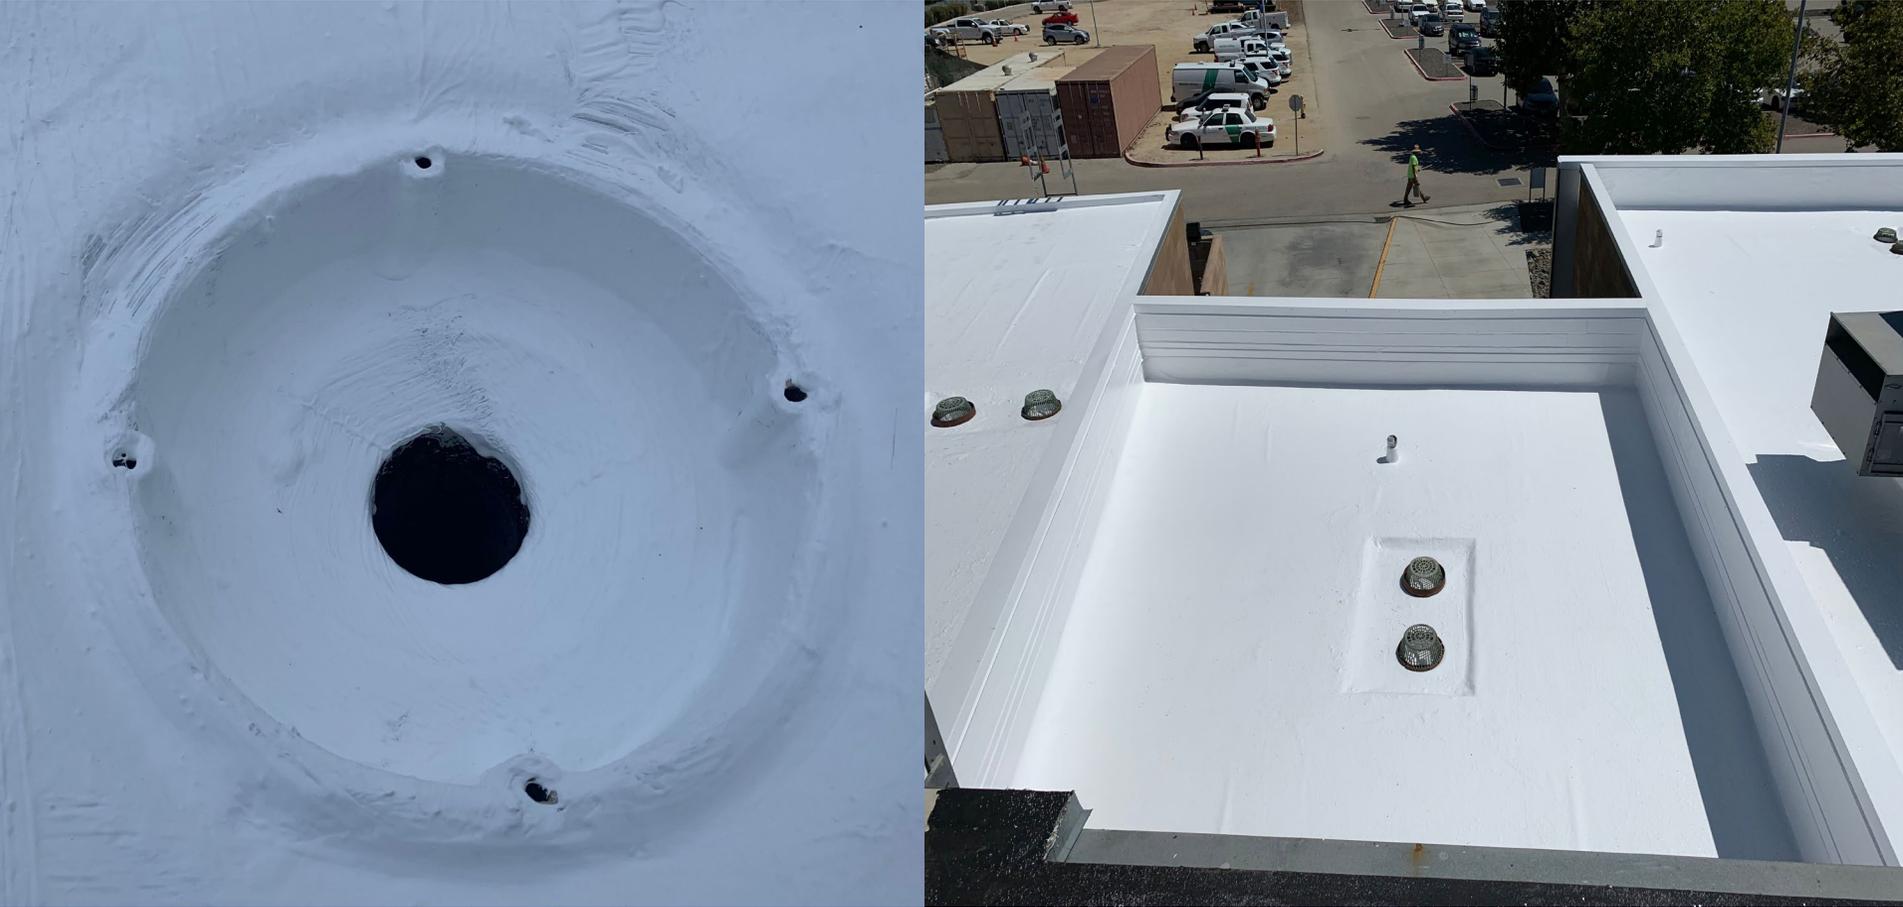
DRAINS are encapsulated with a new rubber membrane and reinforcement fabric embedded into the seamless membrane roof system. The final top coat is waterproof, 40mils thick, white UV stable silicone, and drops surface temperatures.

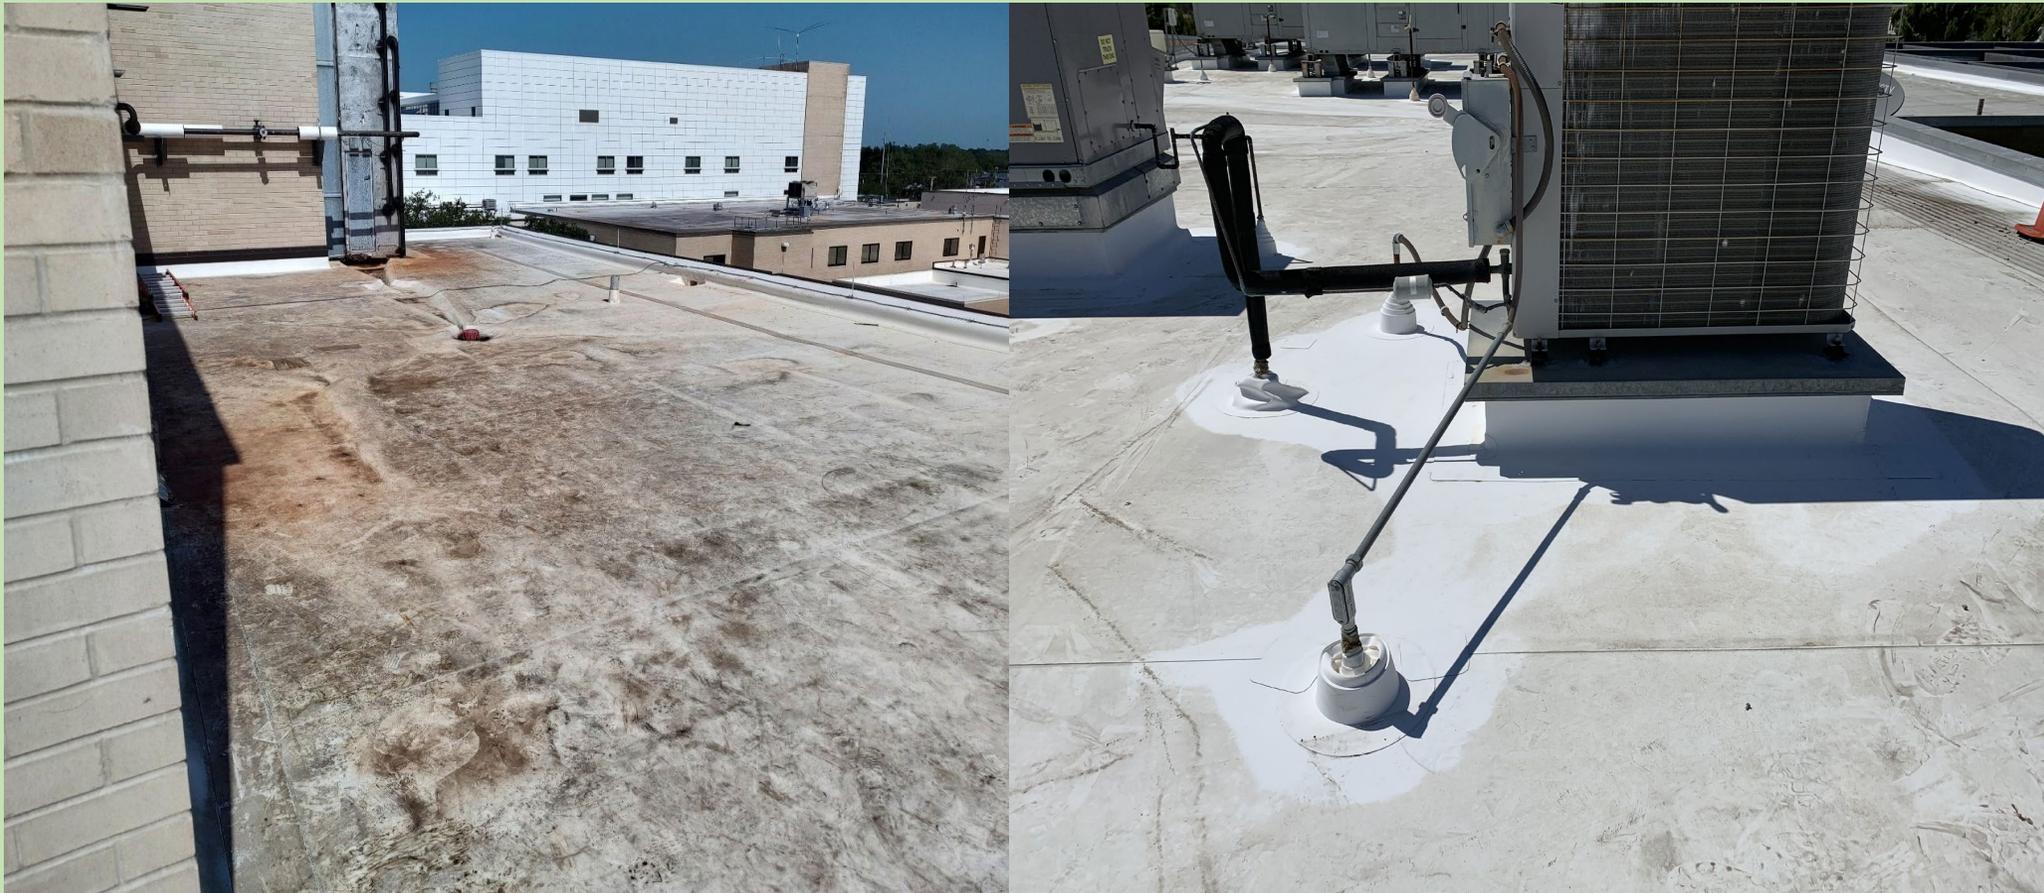
The picture on the left shows an old TPO membrane that requires cleaning before maintenance and repair. The picture on the right shows TPO cleaned around equipment, with IPP Wash & Prime. This provides a surface for rubber emulsion to bond to and build a base coat for the 250HS silicone application.

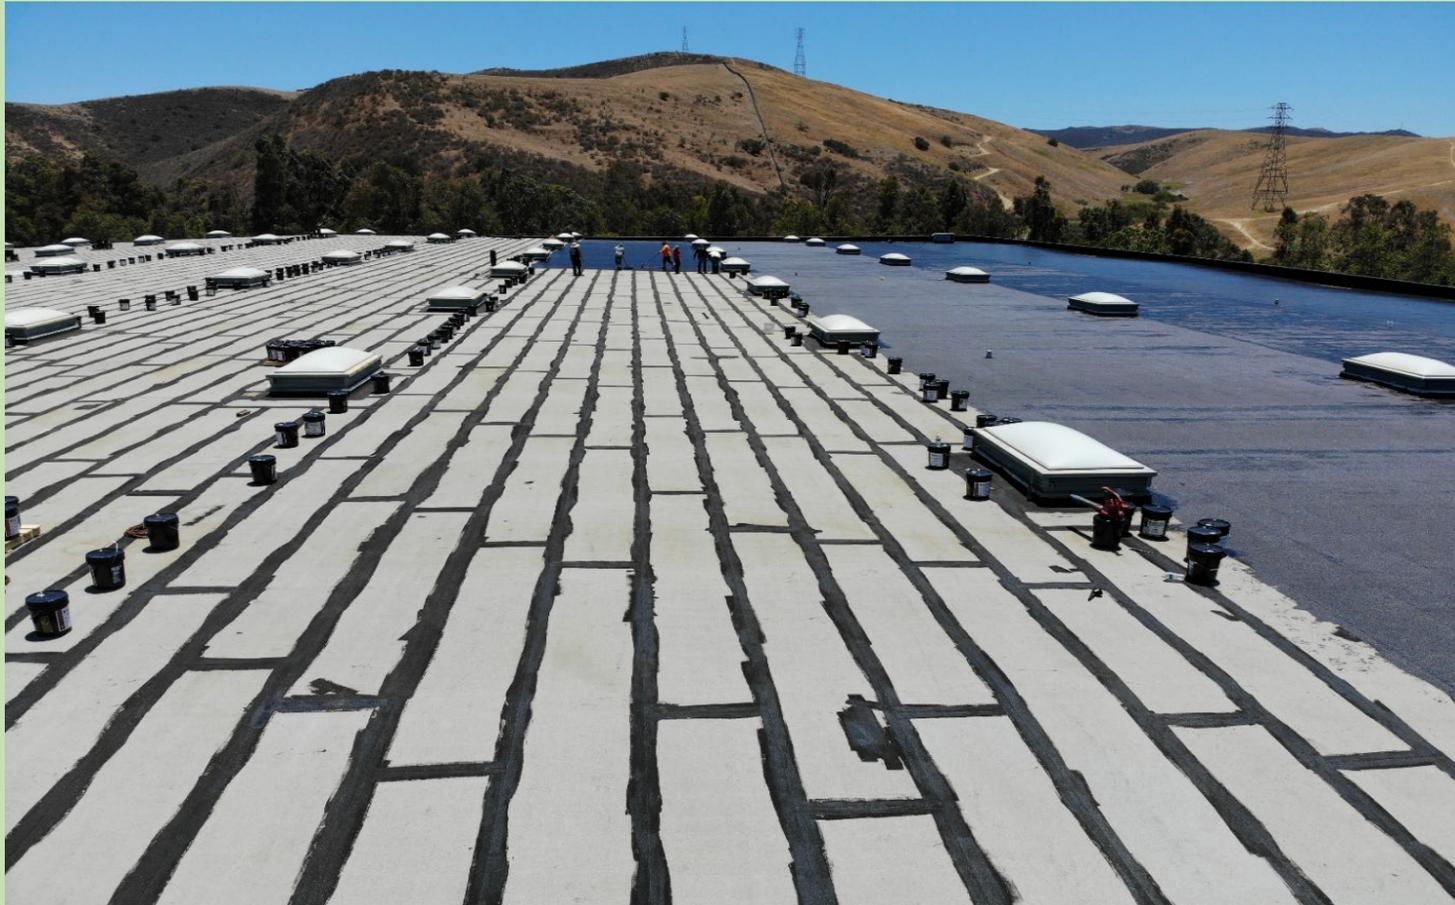
Cap-Sheet Roof: All seams are coated and detail work around equipment and sun-roofs. Seams were treated with 60mils of rubber, then coated with 80mils of rubber emulsion creating a sealed, seamless deck. The capsheet on this deck was old and needed to be completely coated with rubber emulsion providing a brand new roof membrane. Once the primer and 250HS Silicone is applied the thicknesses will be: seams 190mils and deck 130mils thick. (Full SRRS system)

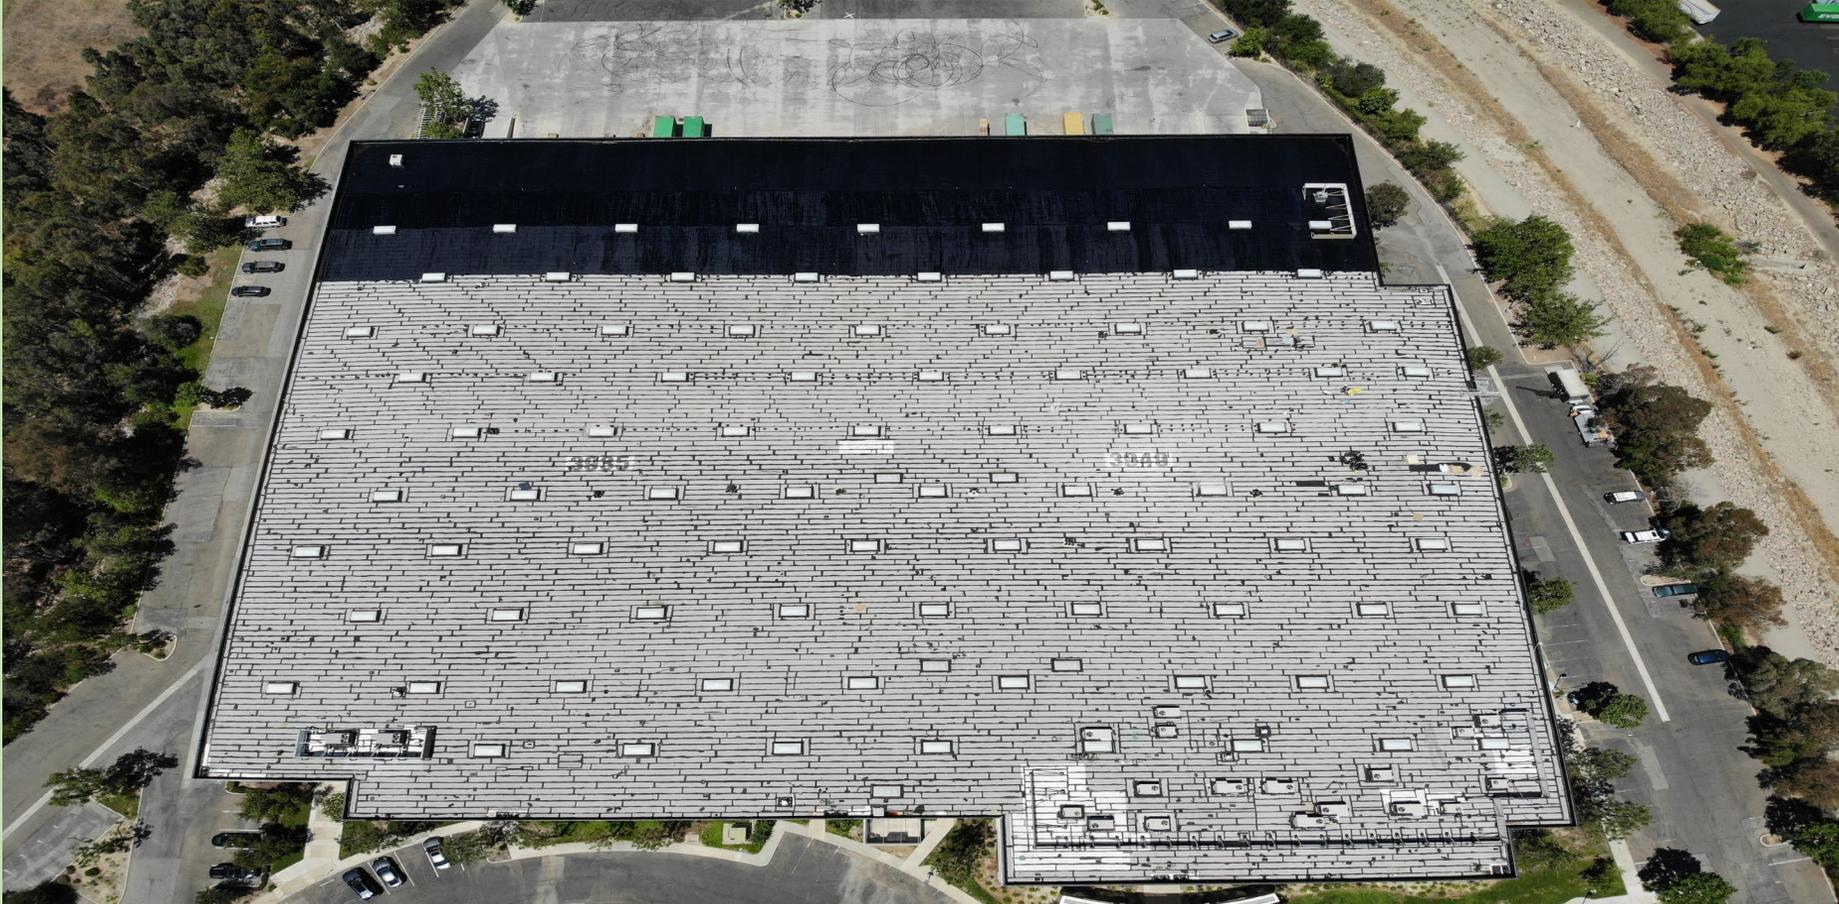
After the seams cure, the entire deck is coated with 80mils of rubber emulsion, sealing the entire roofing envelope. The next step will be to coat the deck with a primer 10-15mils, followed by 40mils of white highly reflective UV stable 250HS Silicone. (Sustainability Goals—FAR 36.104 Policy and CRRC cool roof)

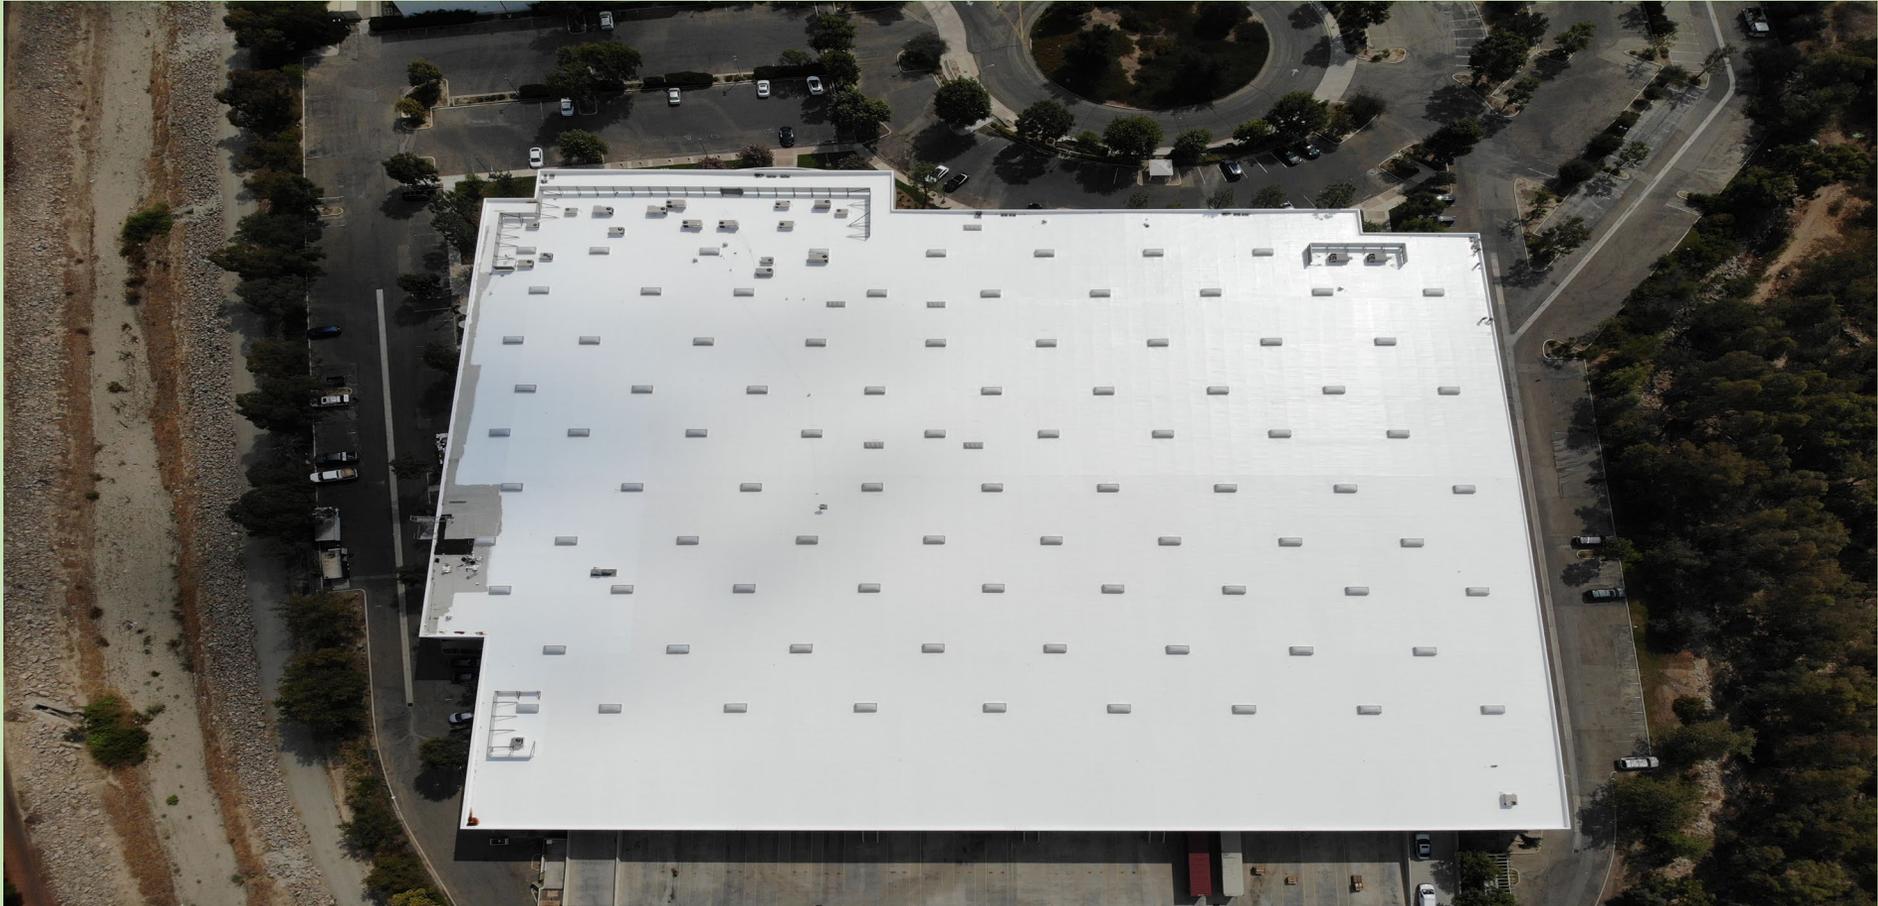
This picture show's the final stages of IPP Silicone Roof Restoration System (SRRS). This provides a brand new roof membrane with a waterproof warranty to ensure decades of use.

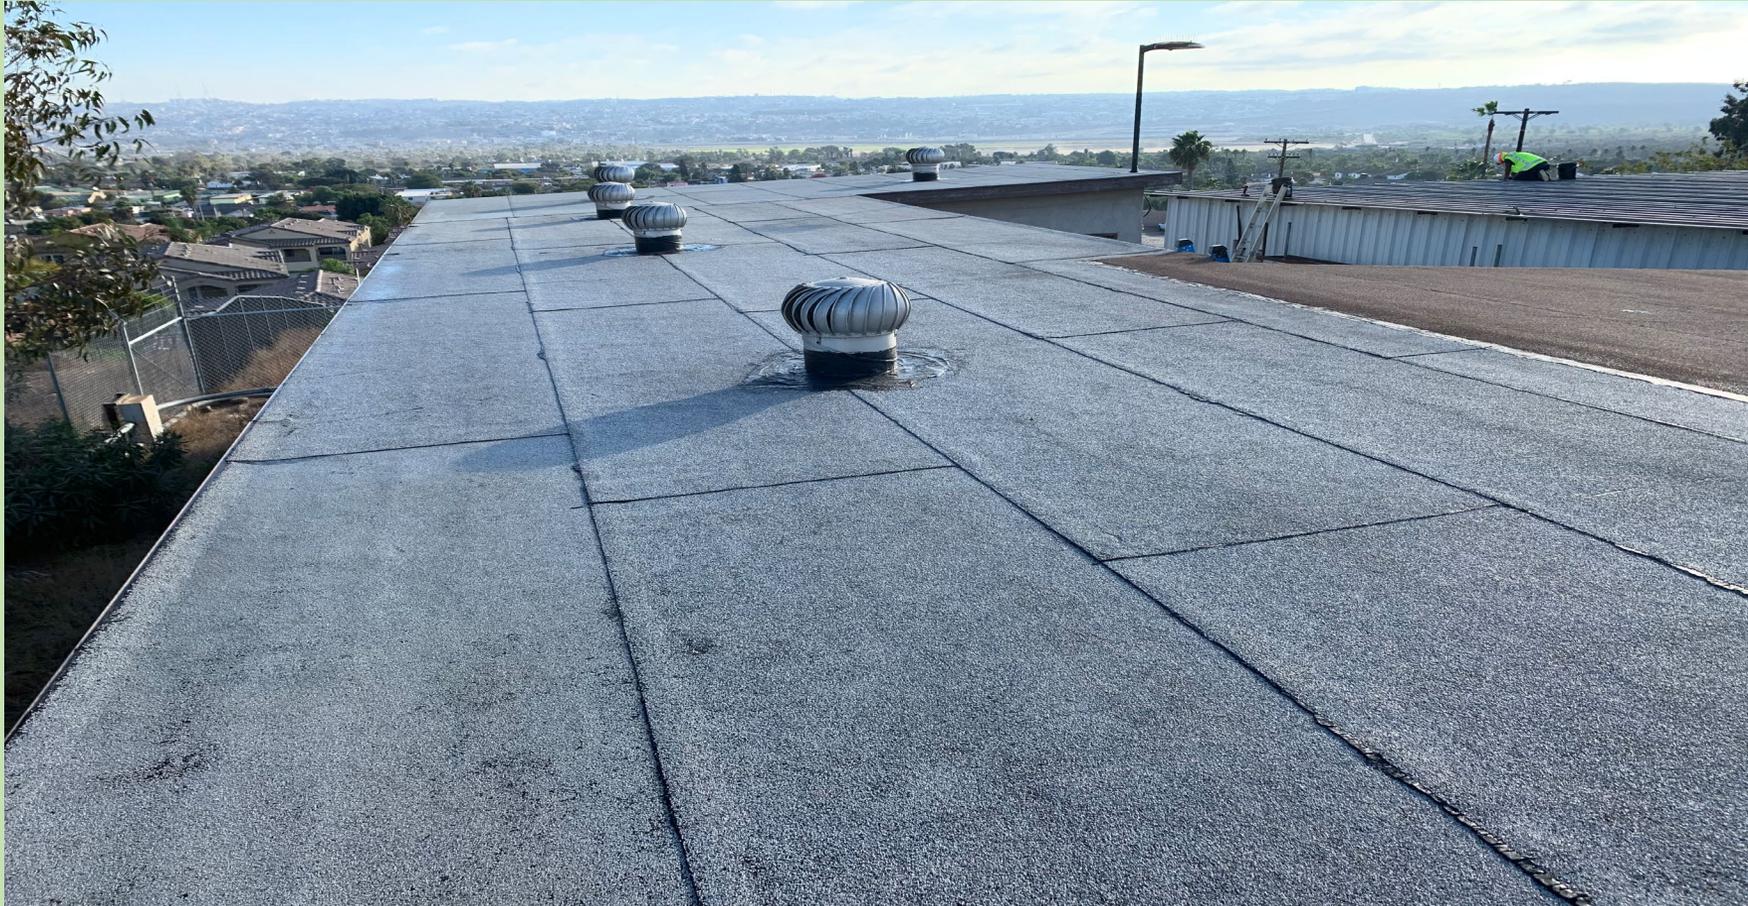
Cap-Sheet, cleaned and ready for rubber emulsion applications for seams and detail work around vents.

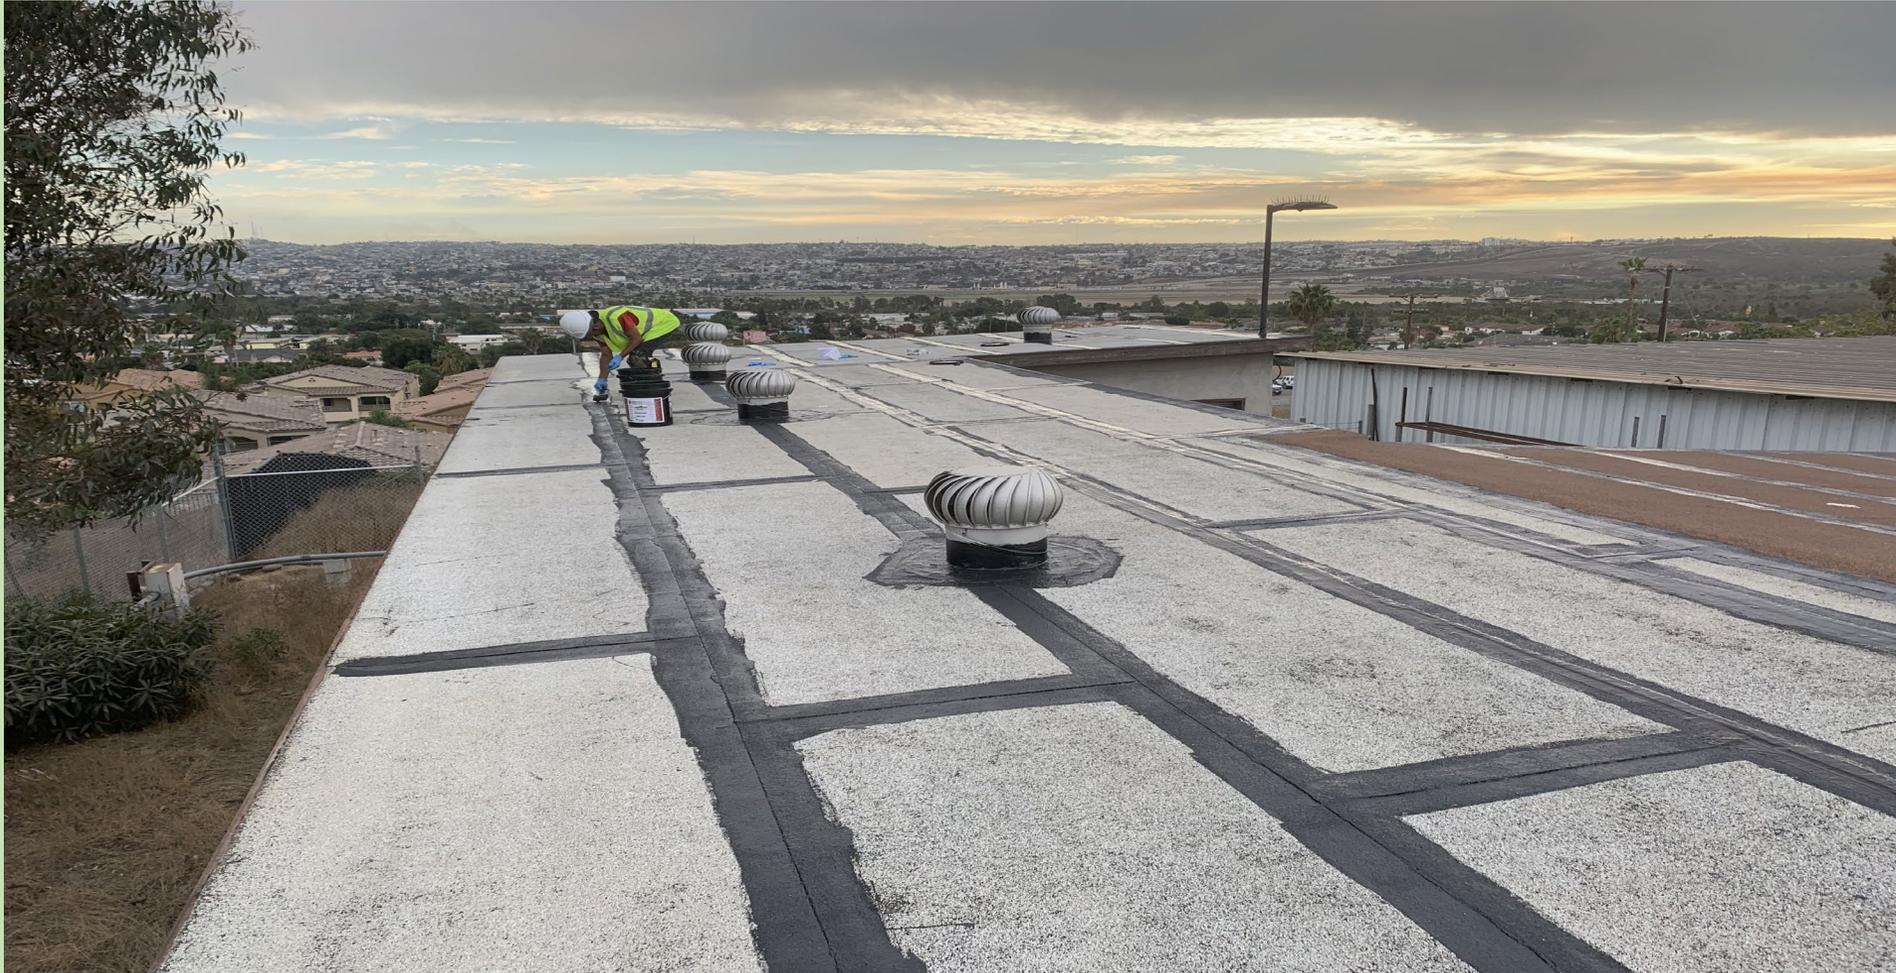
Seams and exhaust vents are sealed with rubber emulsion and reinforced polyester fabric is embedded into the rubber membrane.

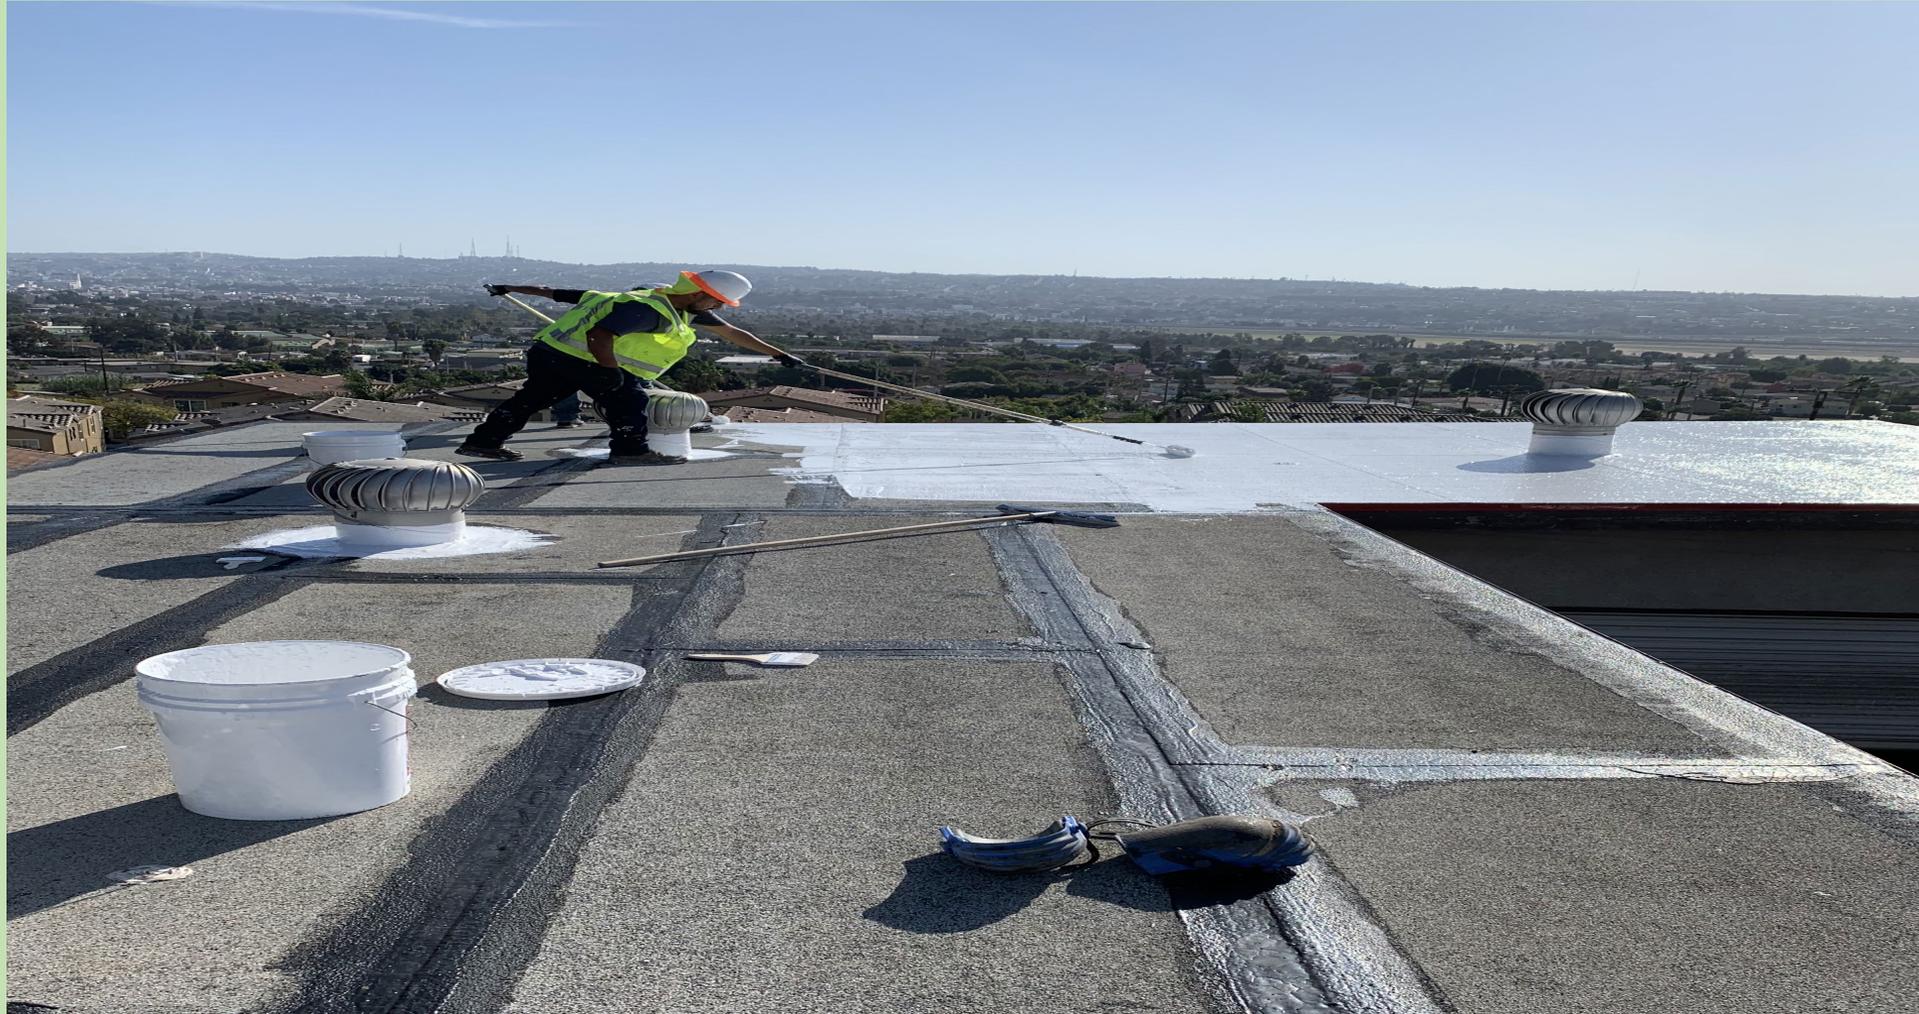
**250HS White Silicone, highly reflective, UV stable, does not break down in ponding water, drops surface temperatures and meets EO/FAR Sustainability Guidelines.
(Energy Reduction, Cost Savings, Heat Island Effect, Construction Waste Reduction)**
