Department of Veterans Affairs JAHVA/Tampa, FL

IPP roofing product demonstration, applications for different roof systems.

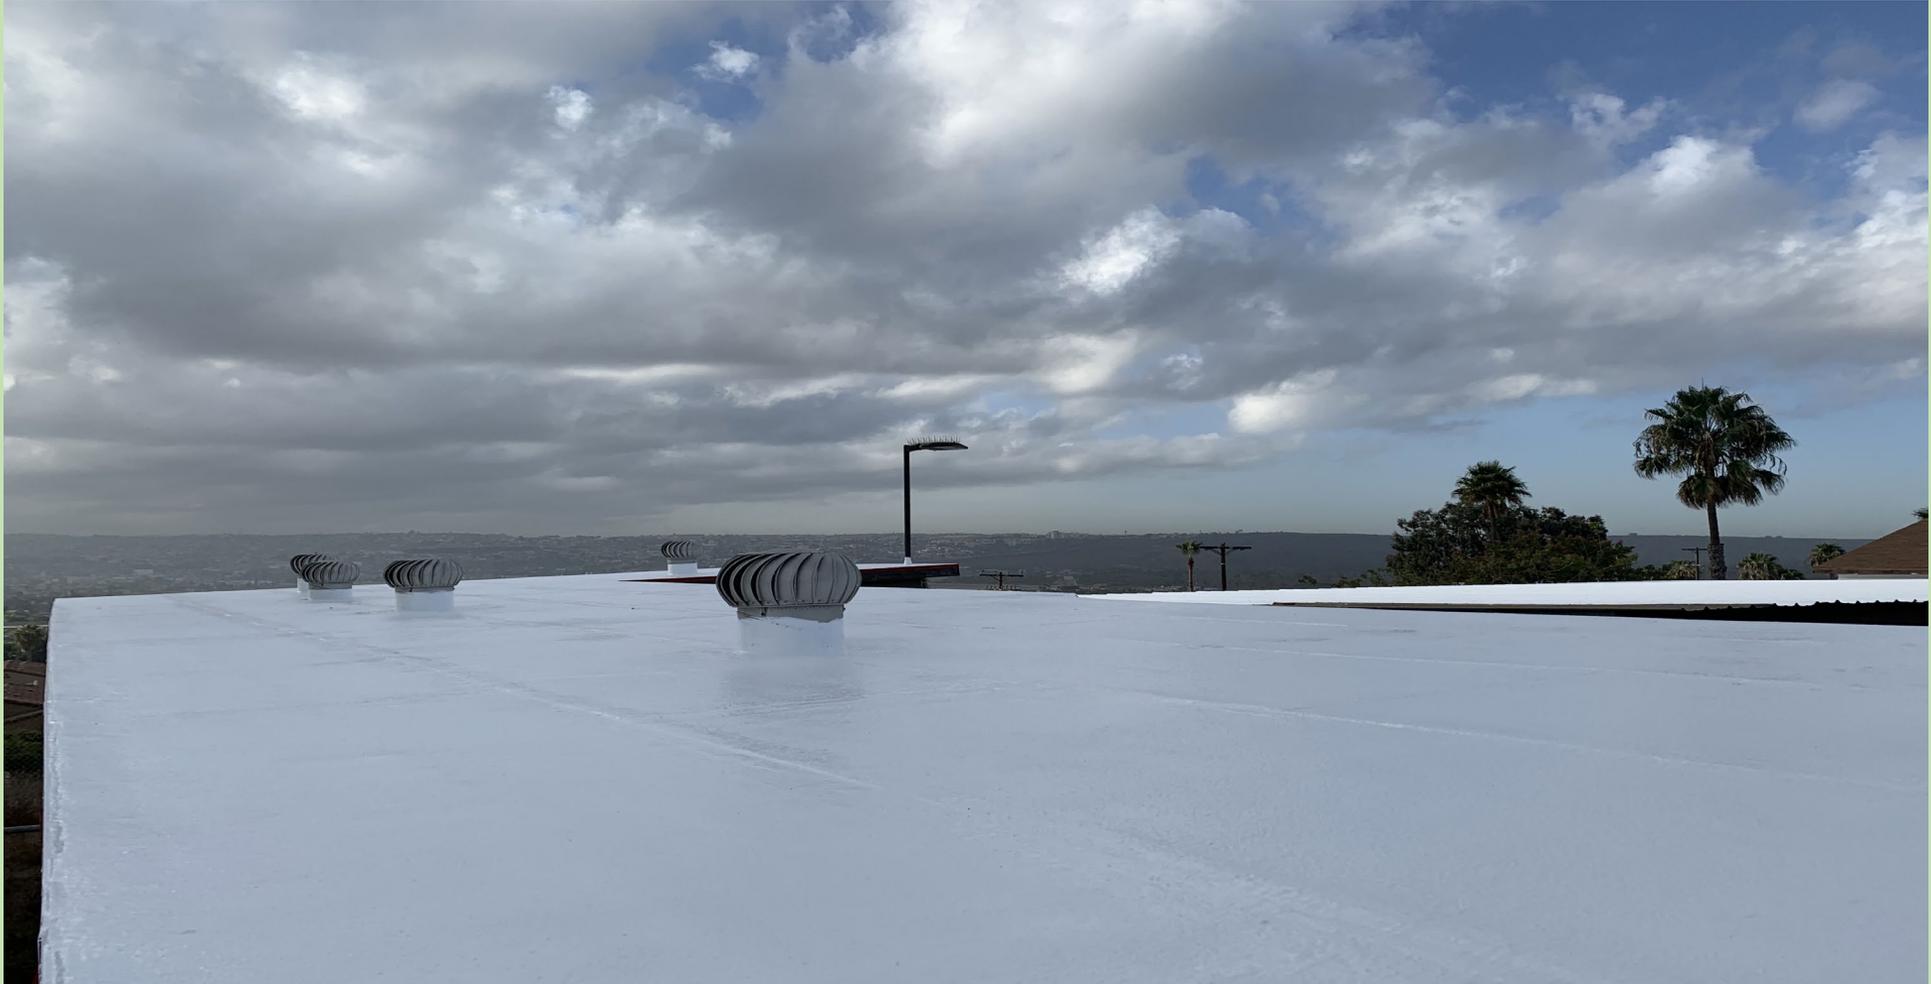
**The cap-sheet is now sealed and top coated with 250HS white silicone.
Total square footage can be tracked for agency specific sustainability goals.
LEED Silver, FEMP, DOE-Better Buildings Campaign**
