Department of Homeland Security
Customs and Border Protection (CBP)
U.S. Border Patrol (USBP) Station
San Diego Sector

Chula Vista, CA BUCA-0386 and 0483 **BUR Gravel Roof**

IPP Silicone Roof Restoration Systems
(SRRS)

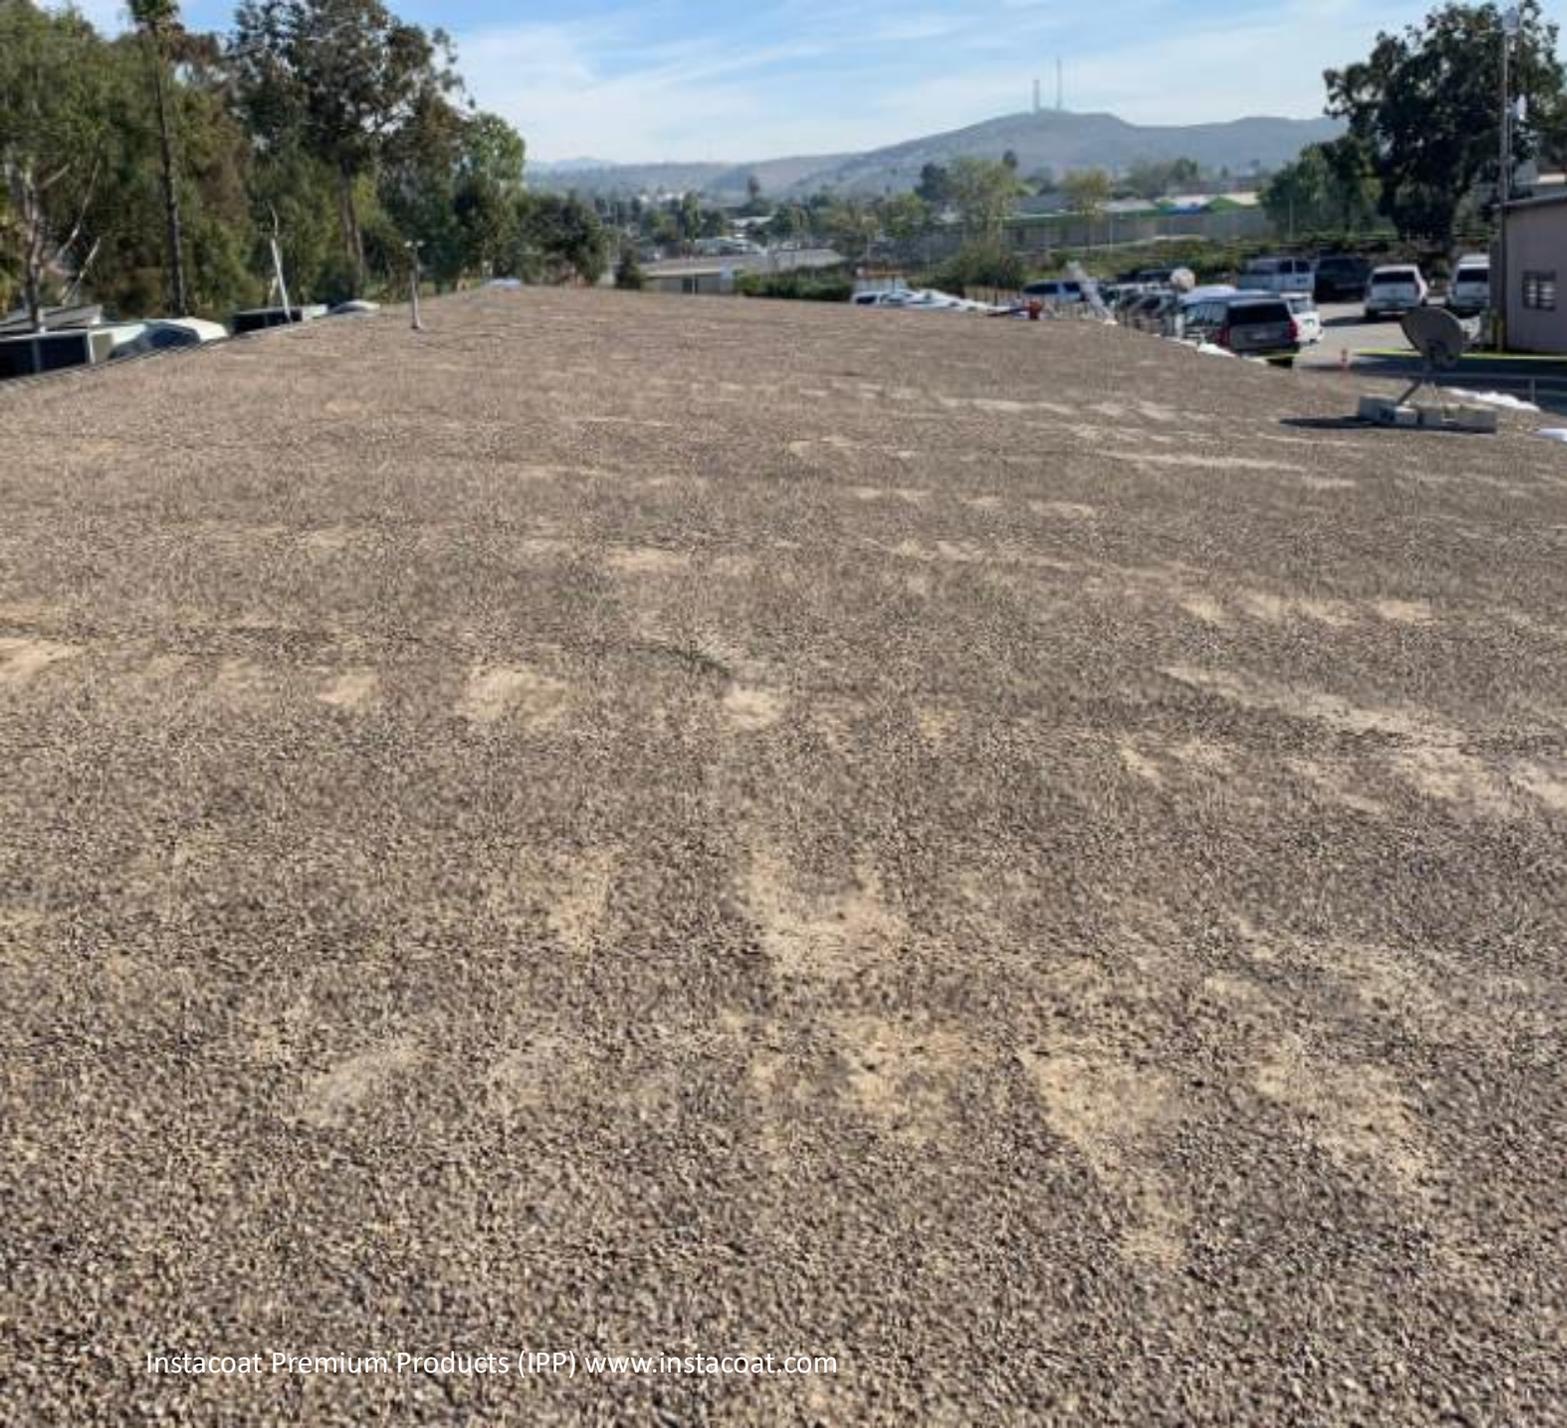
Built-Up-Roof (BUR) Gravel Deck

This old tar and gravel roof surpassed its lifecycle and was failing. The seams split and water was leaking into the facility during rainstorms. Maintenance employees had been chasing leaks on this roof for years. Gravel is used to protect the tar because it's not UV stable and will fail in sunlight, however the gravel also traps and retains heat across the deck. A roof deck 60' x 200' will have 42K pounds of gravel across the deck. The IPP system will remove and recycle more than half of that gravel, reducing the deadload by 21K pounds. On a building like this that's 70 years old with water and termite damage, removing 21K pounds, helps extend the useful life cycle, while improving the structural integrity of the facility.

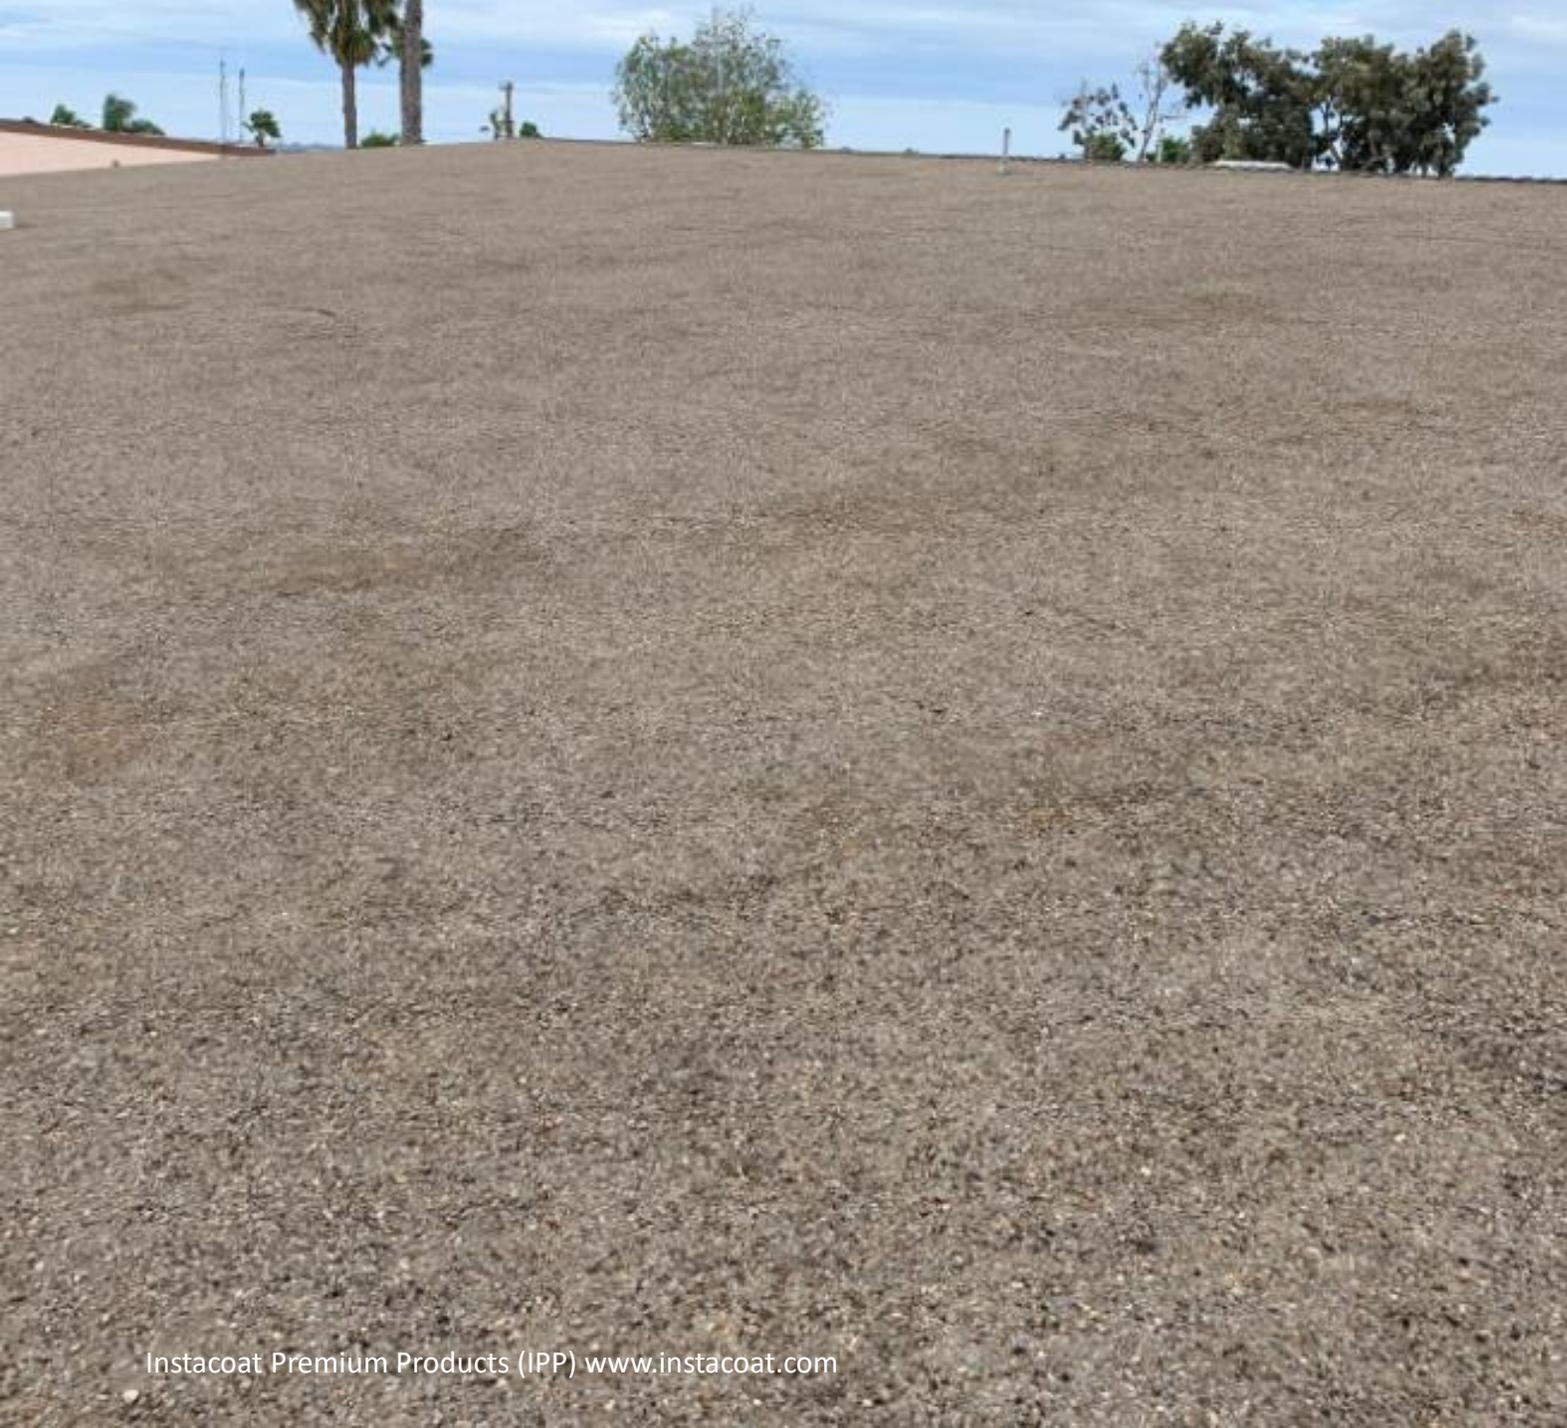
Gravel Removal-Vacuum/Brooms

The loose gravel is removed from the deck and recycled onsite as fill or landscaping materials.

Vacuum systems can be used on large areas, brooms, shovels and dust pans can collect the remaining excess gravel. The picture shows the remaining gravel that's embedded into the old tar roof. This entire deck will be flood coated with rubber emulsion. The liquid will fill all voids, cracks and seams across the deck. When completed this roof will be a seamless membrane of rubber with expansion contraction ratings of 800-1000%. It'll be top coated with customer selected coatings for the site. Silicone—White, Tan, or Quartz aggregates to match existing shingles or cap-sheet.

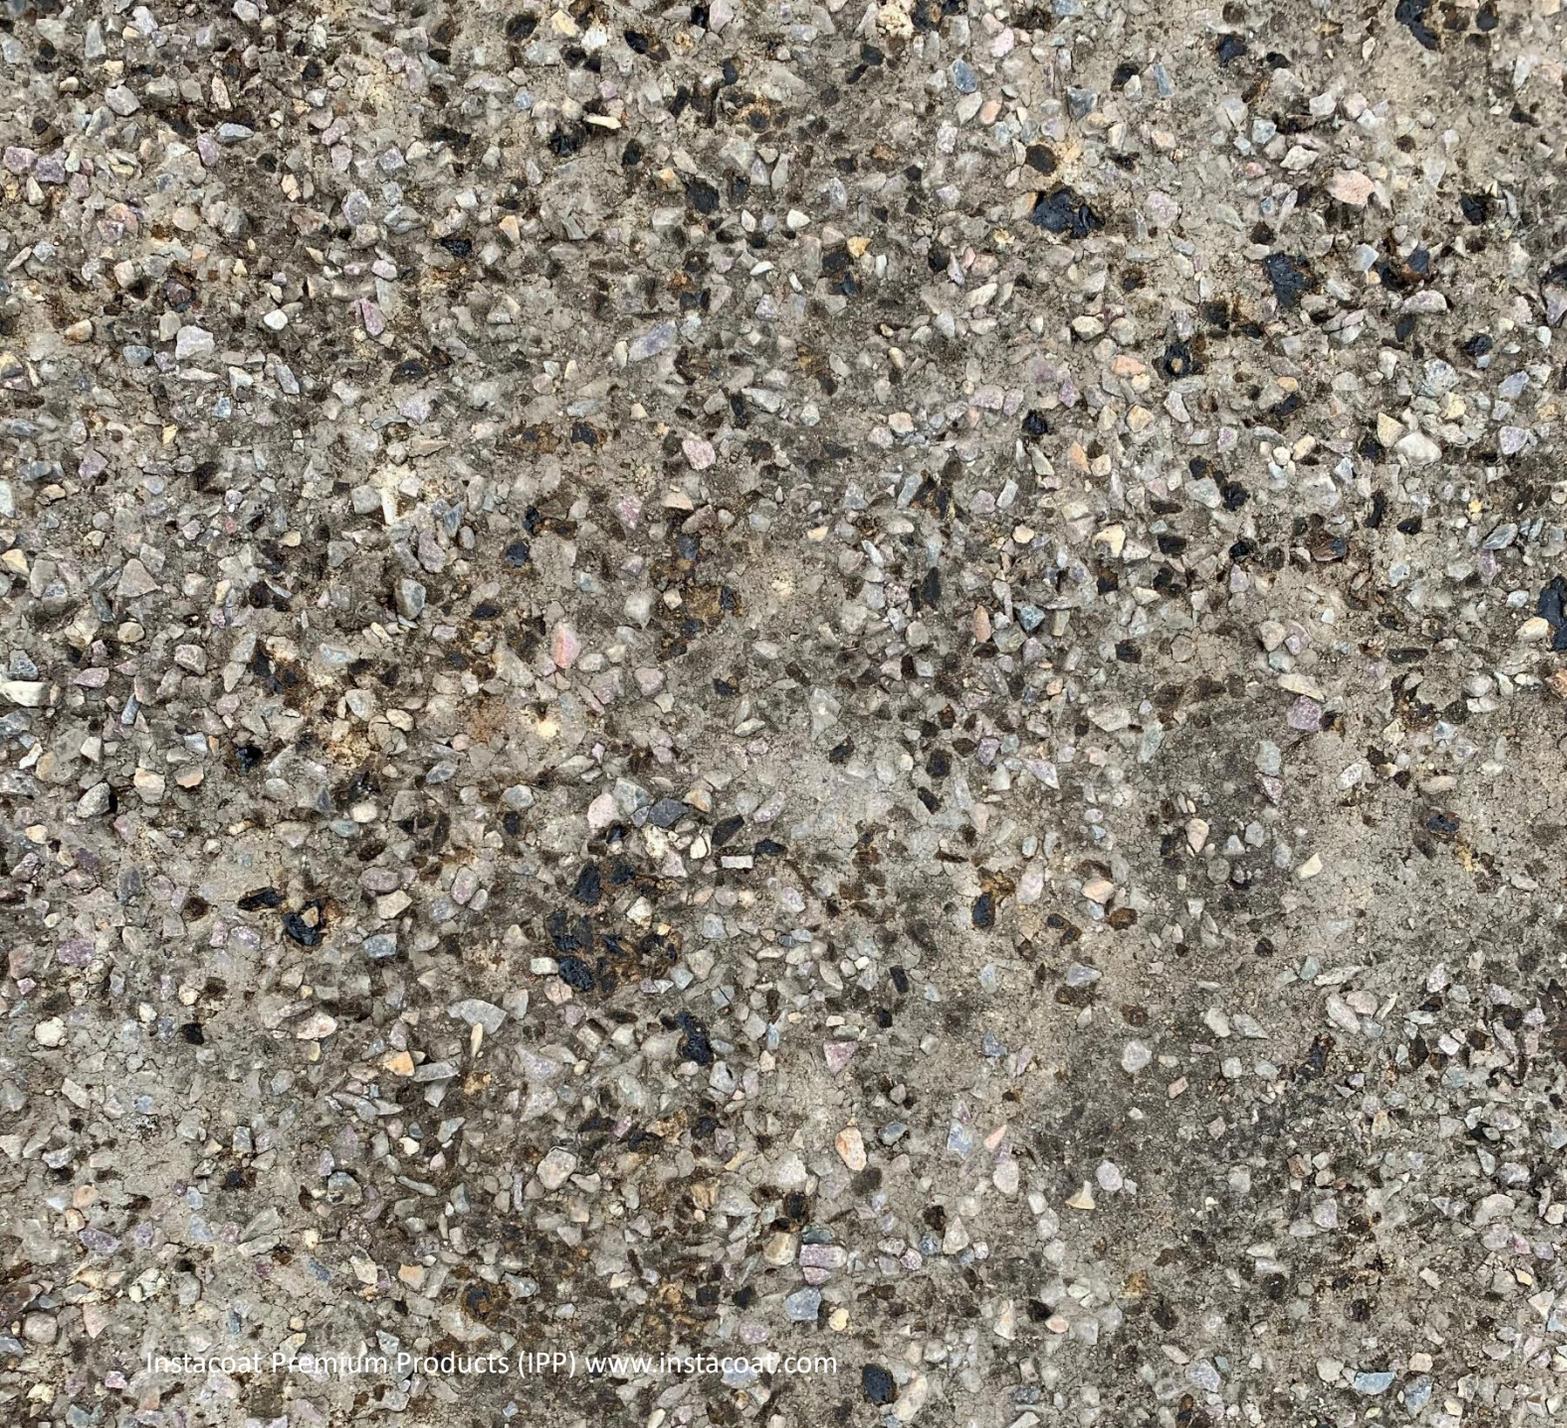
Remaining Gravel to Flood Coat

This gravel will remain on the surface and be coated with 80-100 mils thick, neoprene asphalt rubber emulsion. The old gravel surface retained heat and didn't have the solar reflective properties of today's cool roofs. Silicone can be selected in many colors, however, white and tan are generally the selected roof coatings. With BUR roofs after flood coating with rubber, quartz aggregate can be cast into the top layer of rubber emulsion. The quartz comes in different colors to match onsite color schemes. This quartz is a UV stable product that also helps to drop temperatures across the roof surfaces, while protecting the rubber base coat.

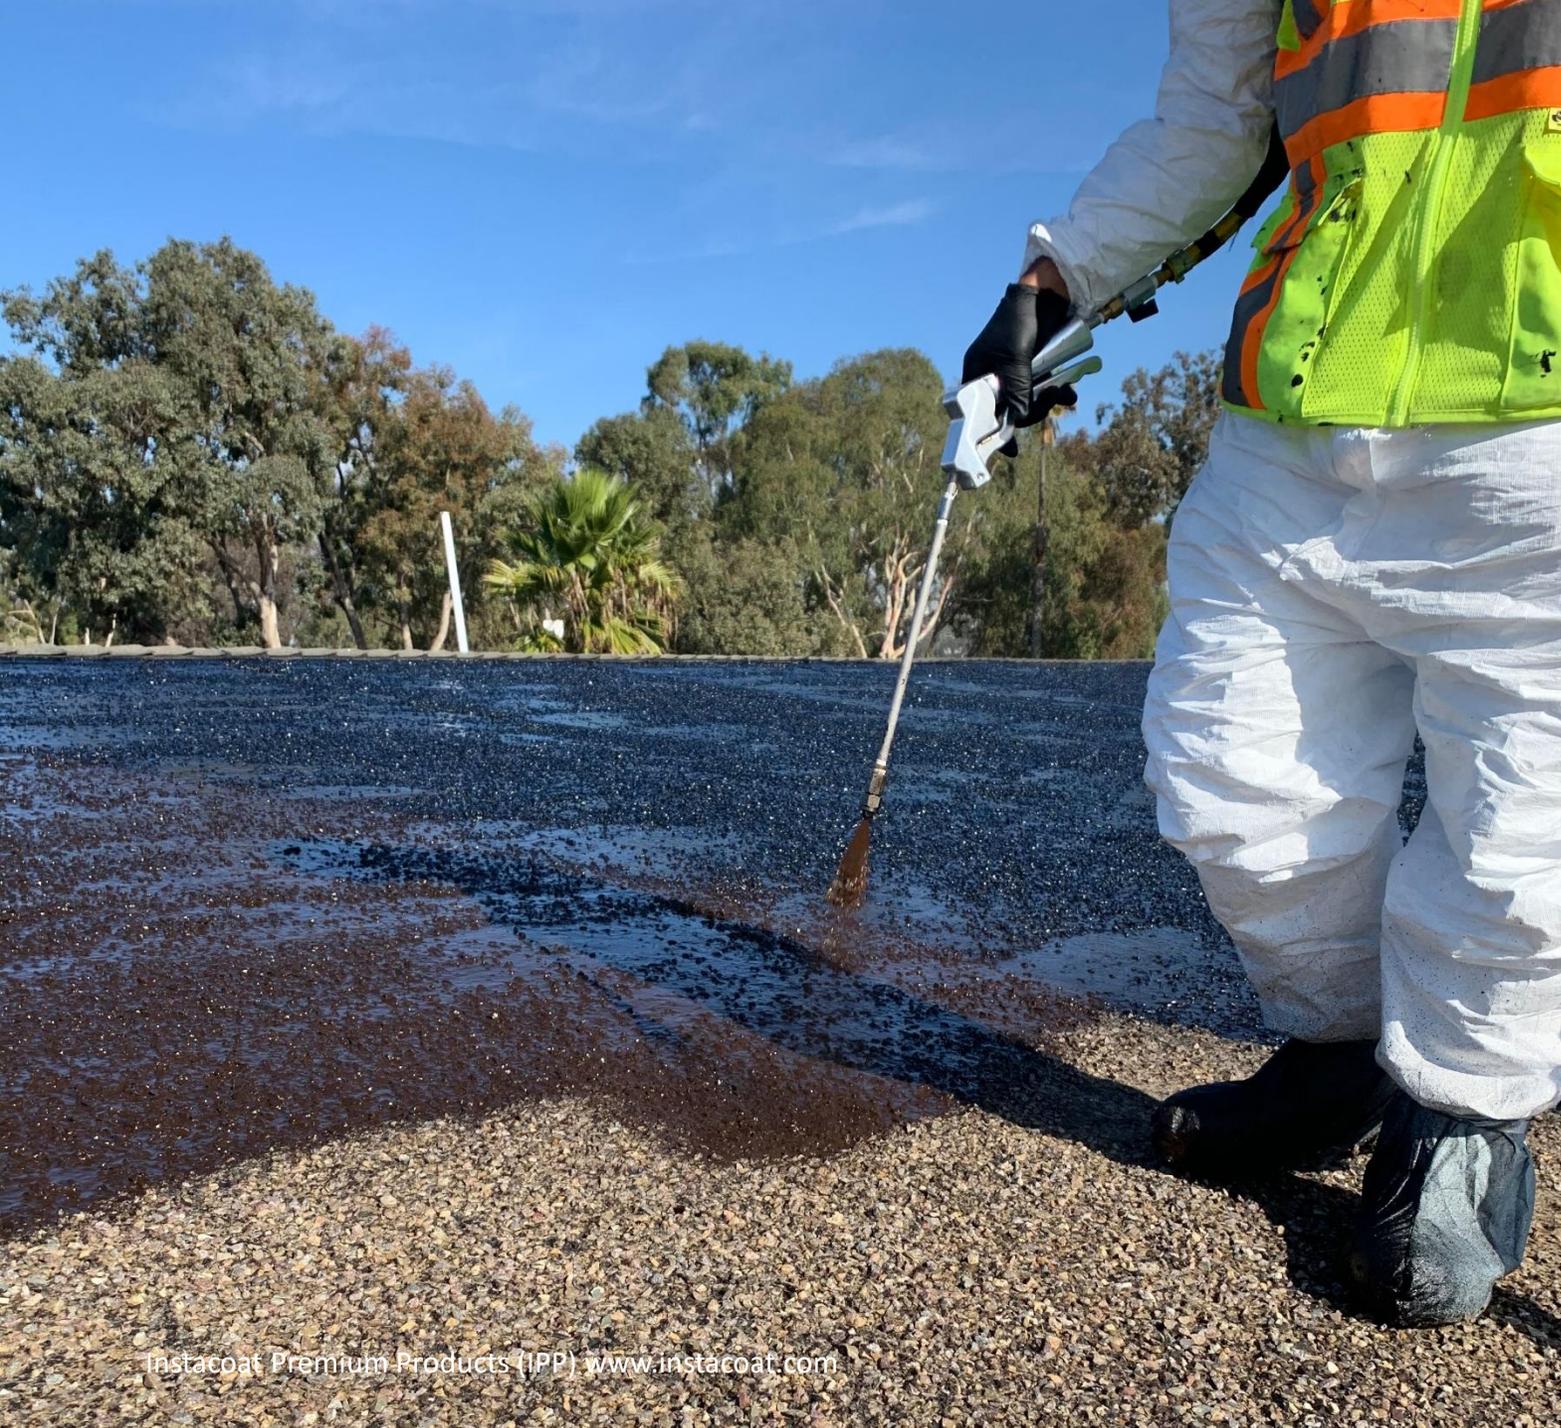
Spray Applied Neoprene Asphalt Rubber Emulsion

The spray applied flood coat, levels out and fills all the voids on the roof deck. Multiple coats can be applied to a desired thickness. This roof had 80-100 mils thick of rubber applied over the old tar and gravel deck. This new membrane sealed all cracks, seams, penetrations and voids preventing any further water damage. The roof gravel that was removed averaged 3.5 lbs per sqft and this new roof only adds .3 lbs per sqft. So, the new roof is 17,400 pounds less deadload than the old system.

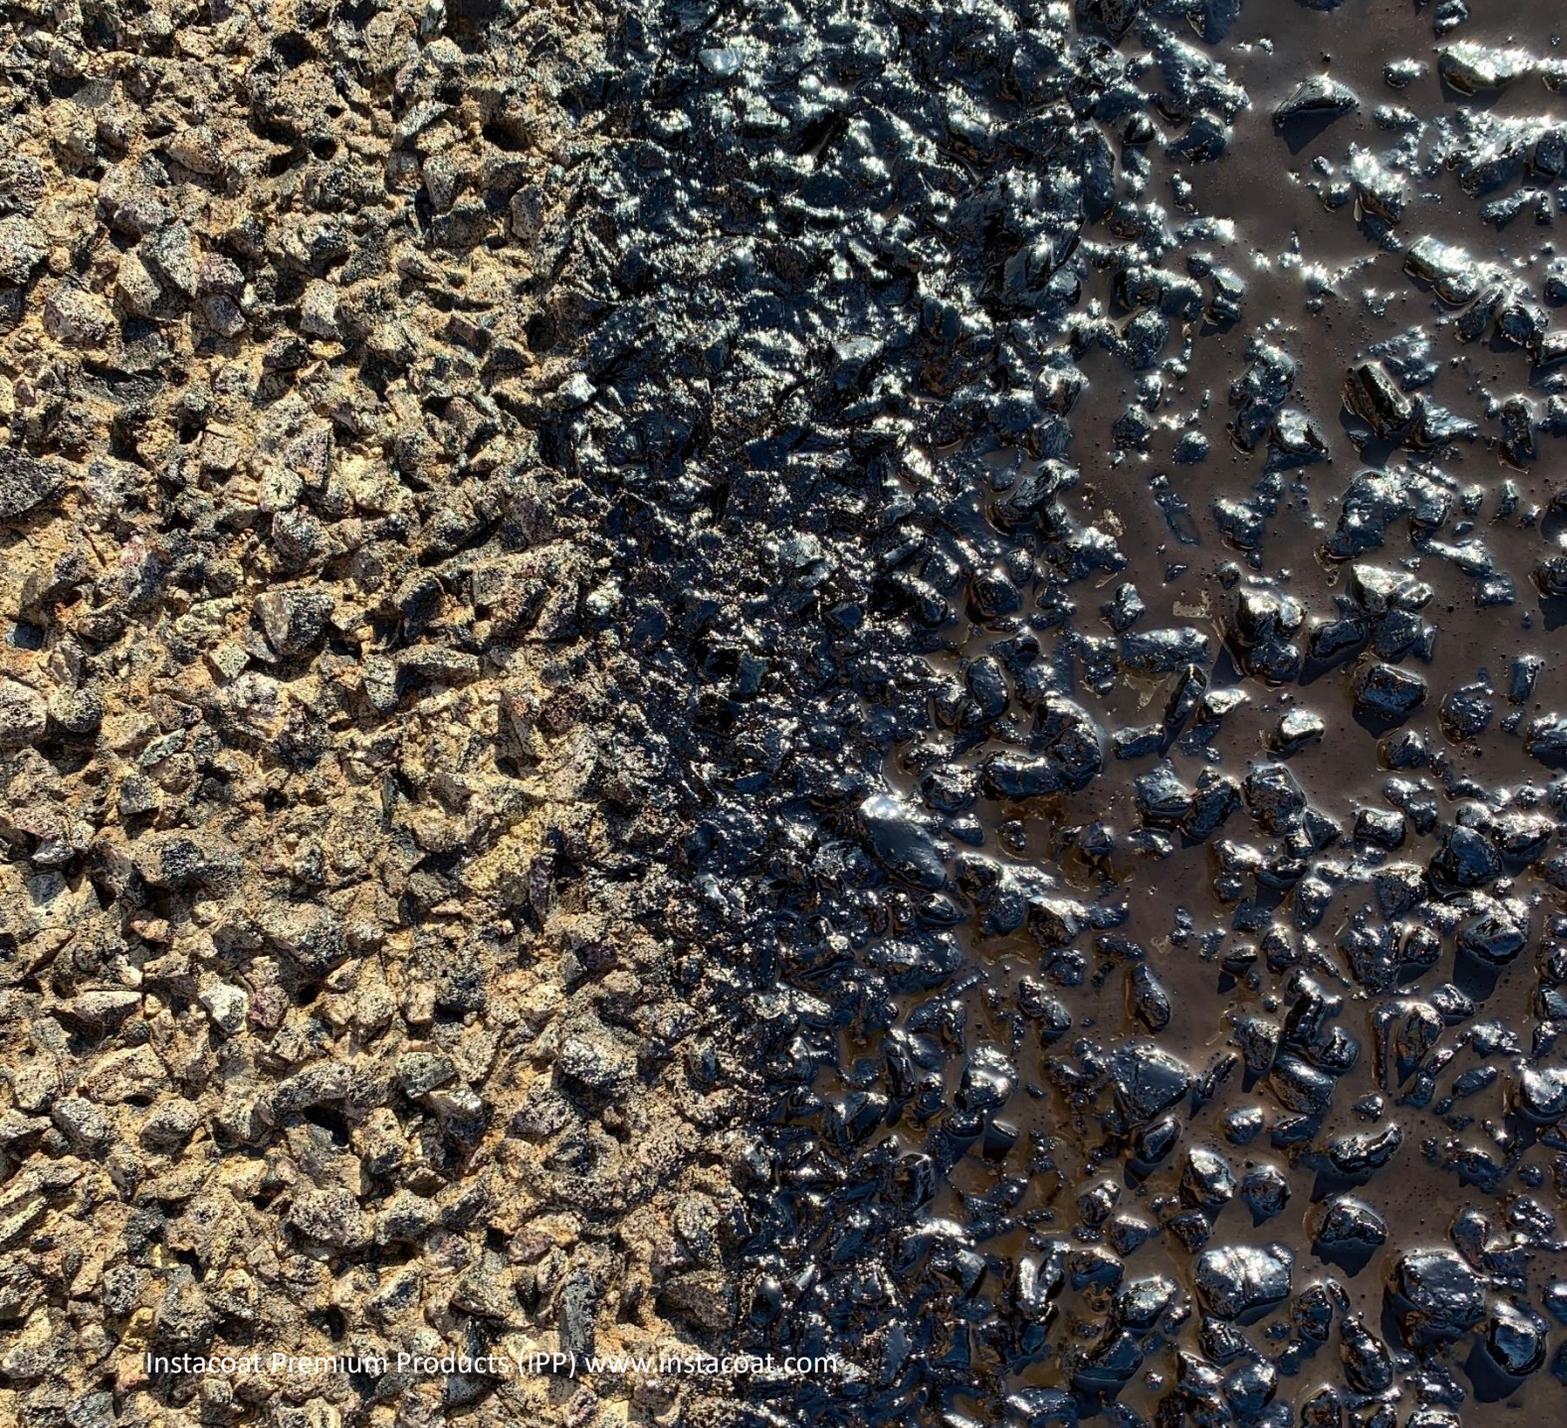
New Rubber Emulsion Membrane

Not removing the deck can save hundreds of thousands of tax dollars. At the same time meeting federal sustainability goals, by reducing construction waste. The roof was left in place preventing over 100K lbs of construction waste being dumped into a landfill. This saves tax dollars on labor, because there's no demolition, savings on dump fees, dumpsters, dump truck costs, etc... If these are eliminated, then Co2 emissions are also reduced. Remember, this is a cold applied system, so there's no hot tar kettles or torch applied systems; which all emit Co2 into the atmosphere. The IPP roofing systems meet or exceed federal sustainability goals: Executive Order 14005, 14008, and 14057 Federal Acquisitions Regulation (FAR) 36.104 Policy EPA and DOE goals are also met, the links are on the last slide for market research

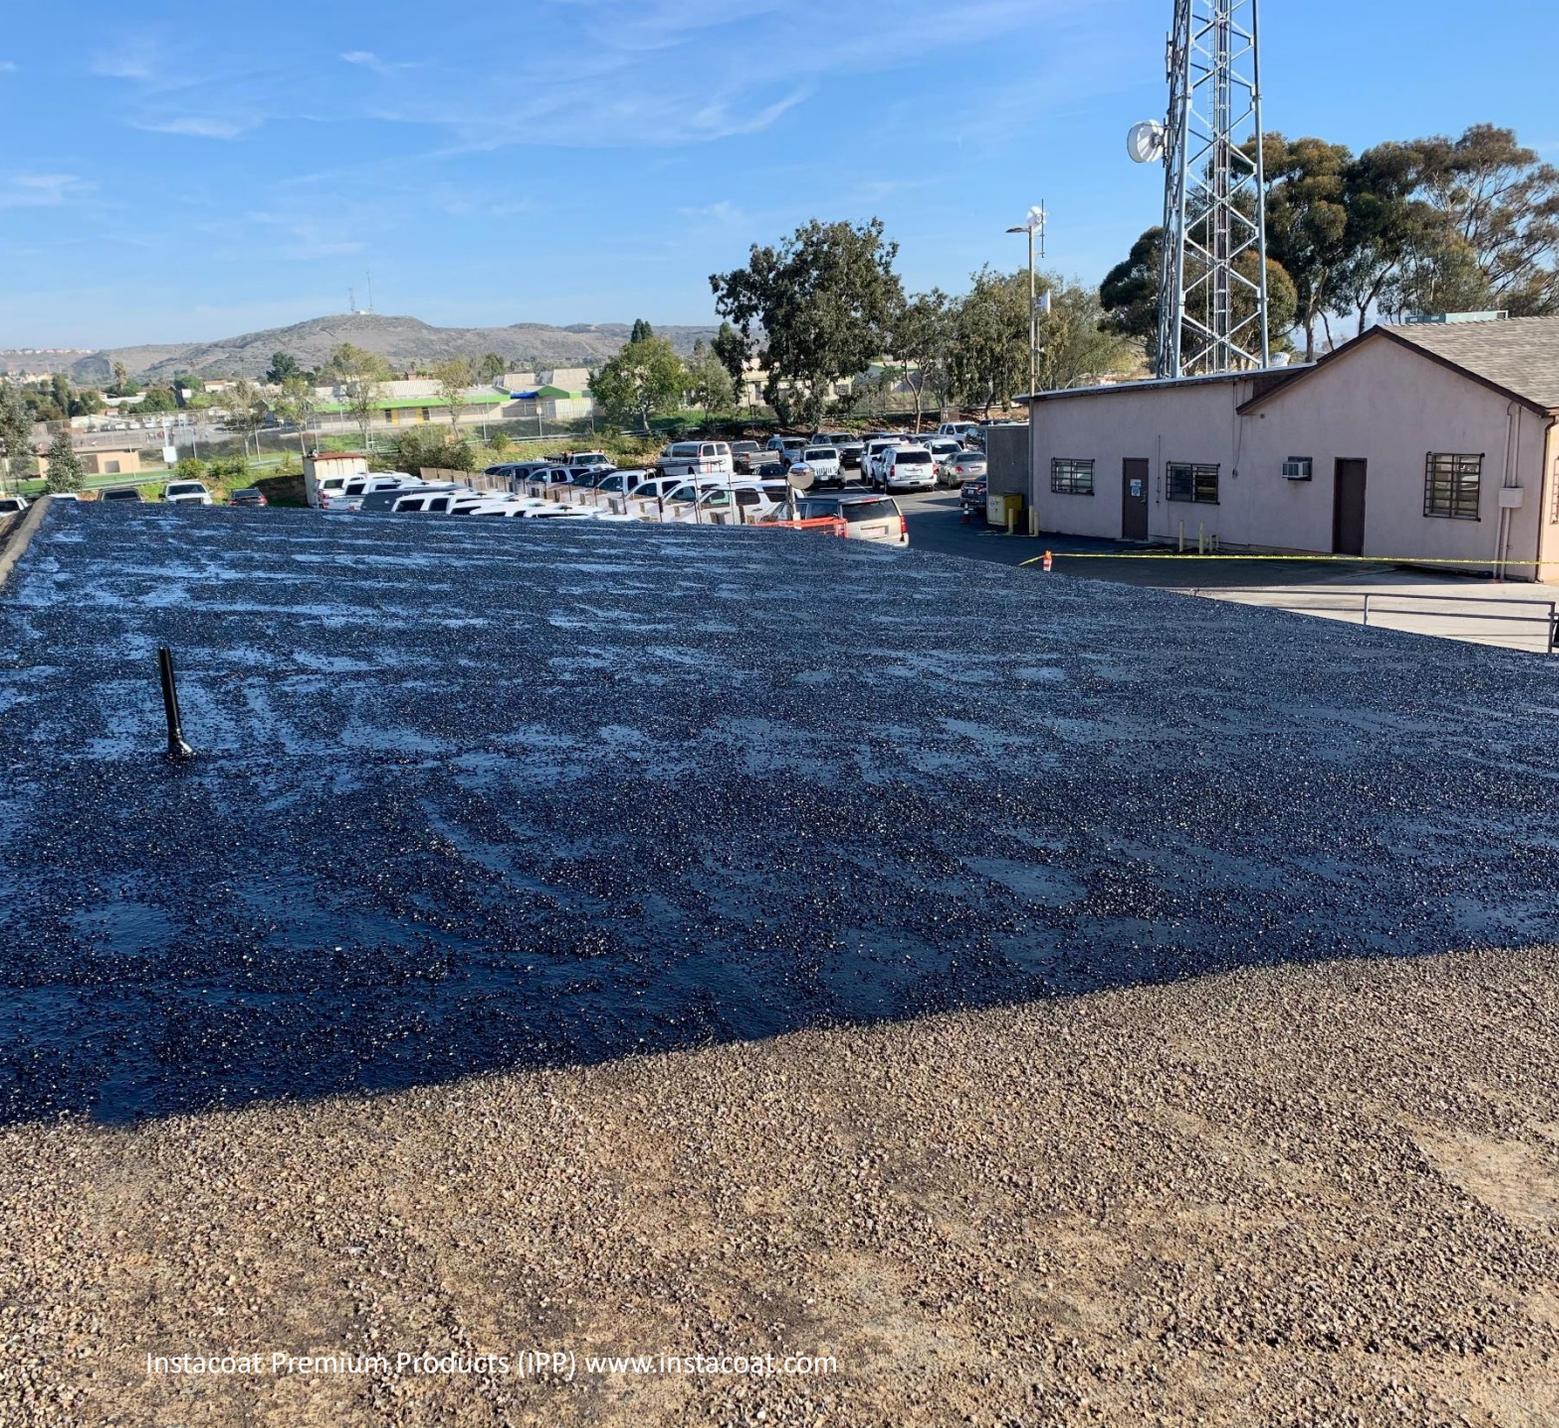
Spray applied flood coat over BUR

This shows how fast and easy the system is to apply. Once the excess rock is removed, the material is applied easily across the roof deck. This first coat will cure and the second coat will be sprayed directly over top and form a monolithic membrane. (seamless)

Most BUR, Cap-sheet, PVC, TPO, and EPDM roofs all fail at the same locations—seams. Having thousands of linear feet of seams to fail is not comforting when paying for a new roof. So, an IPP roof provides zero worry from seam failure because its seamless. Also, any penetrations or seams on the old decks are reinforced with fabric embedded in rubber emulsion. This added step ensures 800-1000% elongation properties stand up to expansion/contraction for decades.

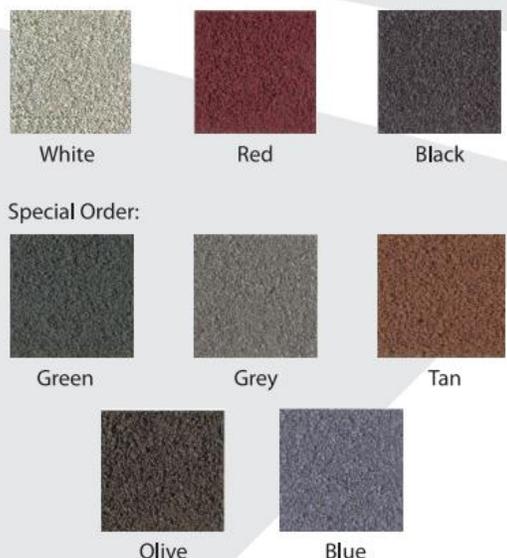
Final Coat of Rubber Emulsion

This roof was selected for quartz aggregate to match existing roofs with cap-sheet or shingles. The next step for this project is to cast in aggregate, which will bond to the rubber and provide a UV stable topcoat. Any excess aggregate can be collected and cast into the next roof section. This is a great example of taking an old roof and restoring it with a new membrane holding a 20-year warranty.

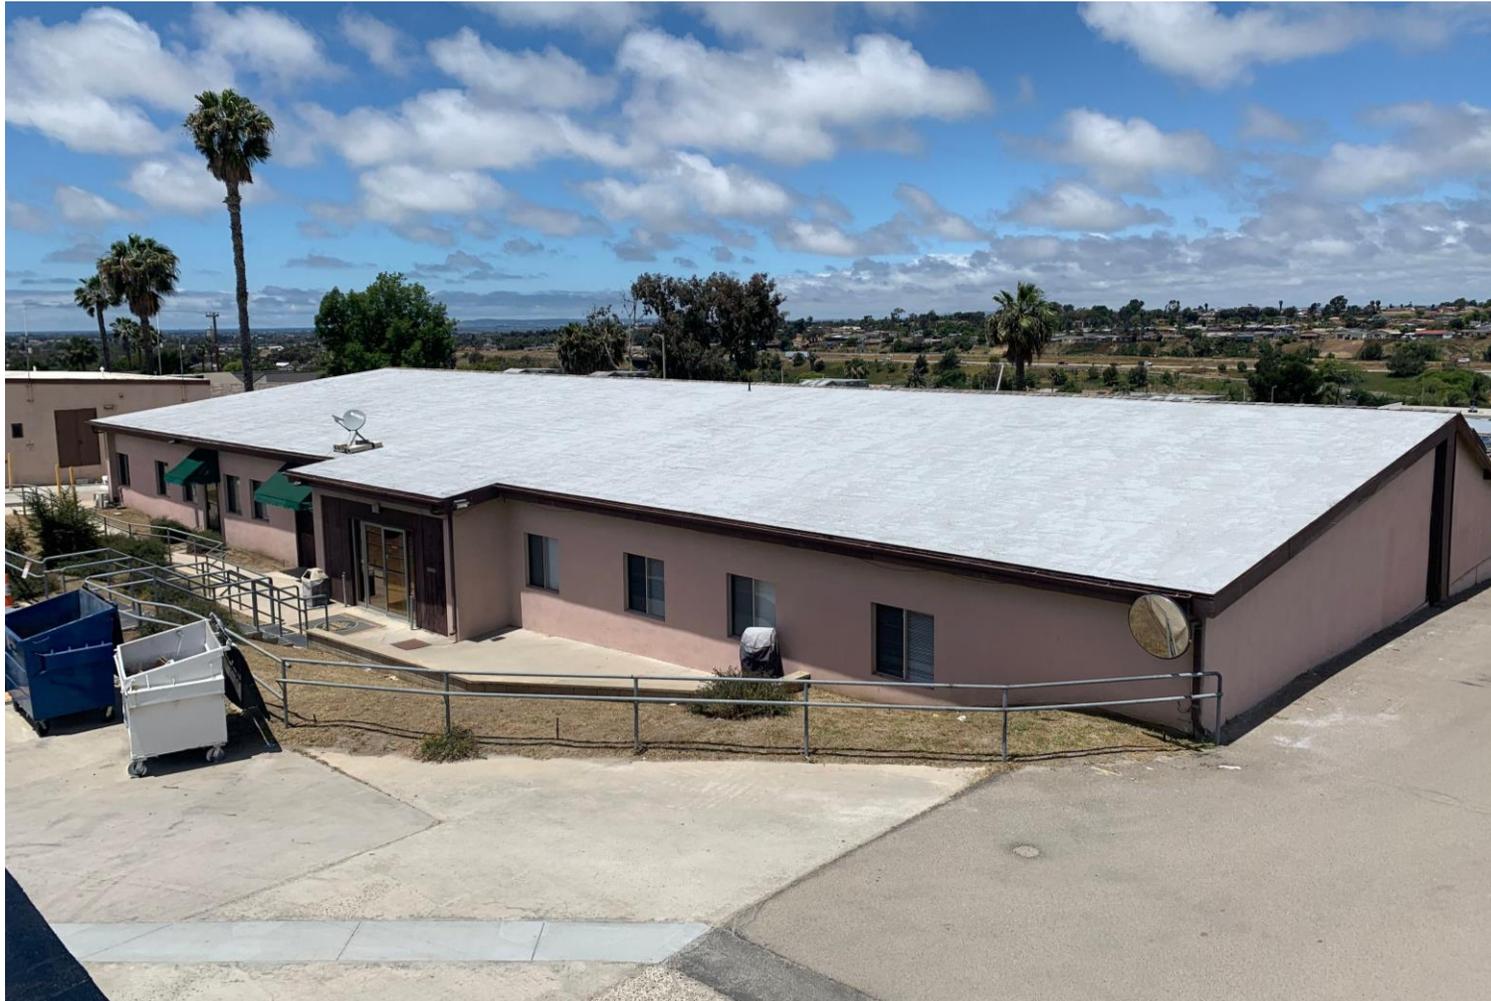
Aggregates Cast on Rubber

This roof was selected for quartz aggregate to match existing roofs with cap-sheet or shingles. The customer selected a gray/white color to reduce surface temperatures across the deck. This is a great example of taking an old roof and restoring it with a new membrane holding a 20-year warranty.
